EDAW, Inc. was contracted by Black & Veatch to conduct a reconnaissance survey and impact analysis report for the Echo Park Rehabilitation Project. The City of Los Angeles (City) is proposing to rehabilitate Echo Park Lake through in-lake basin improvements, in-lake vegetation and habitat improvements, and parkland structural best management practices (BMPs), including grassy swales/infiltration strips, porous pavement, “SMART” irrigation system, and educational signage and kiosks. Potential impacts to biological resources from construction and operations associated with this project are discussed herein.

Echo Park is a 29-acre open-space recreational facility located at 751 Echo Park Avenue, in the Echo Park/Silverlake community of Los Angeles, California. The park is bounded to the north by Park Avenue, to the east by Echo Park Avenue, to the south by Bellevue Avenue, and to the west by Glendale Boulevard (Figures 1 and 2). Of the 29-acre park, Echo Park Lake occupies 13 acres while the remaining 16 acres contains recreational open space.

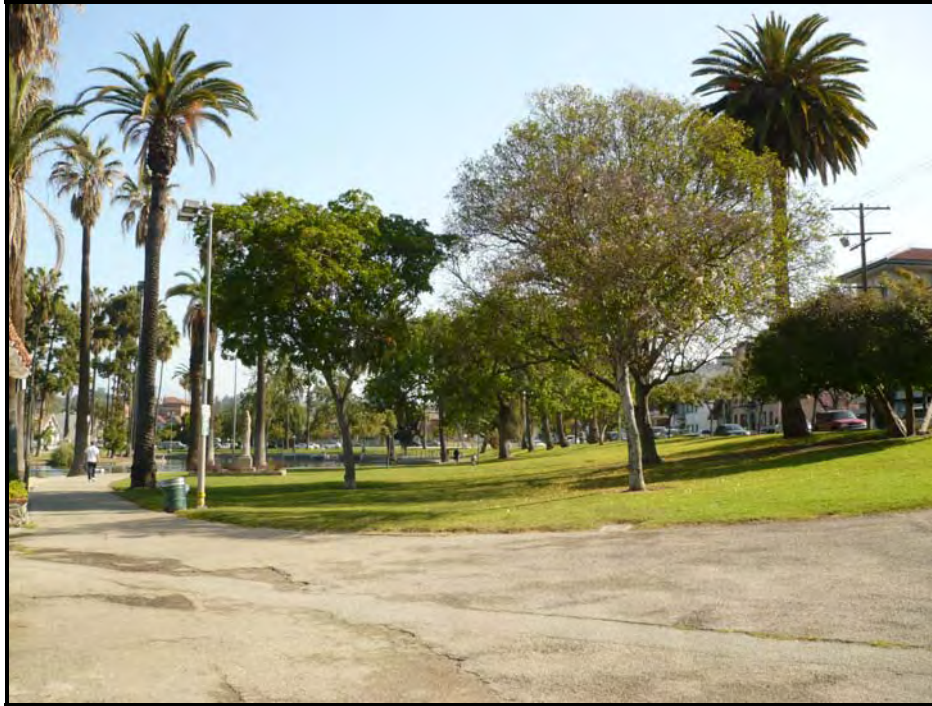
Photo 1. View from the north of the park, southern aspect. Grassy lawn, mature shade trees, and palm trees landscape the perimeter of the park.

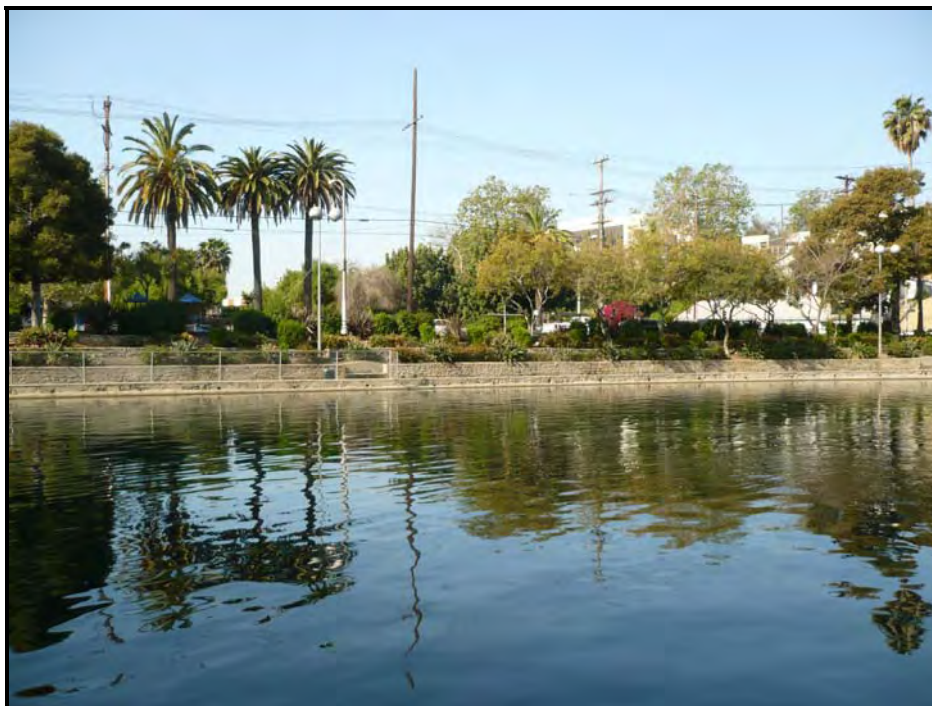
Photo 2. Ornamental shrubs bordering the southern end of Echo Park Lake. Mature trees and palms in the background line the perimeter of the park and Bellvue Avenue.

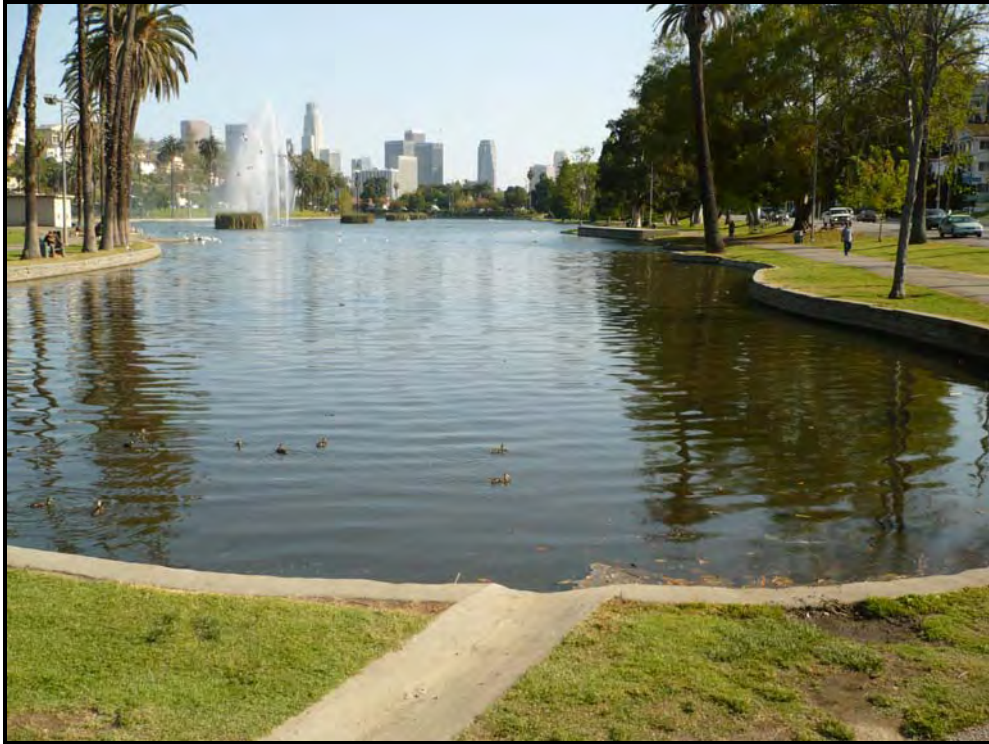
Photo 3. Southerly view of the lotus beds, located in the northwestern lobe of the lake. Four small floating wetlands in background. Lake bordered by mature trees, palms and grassy lawns.

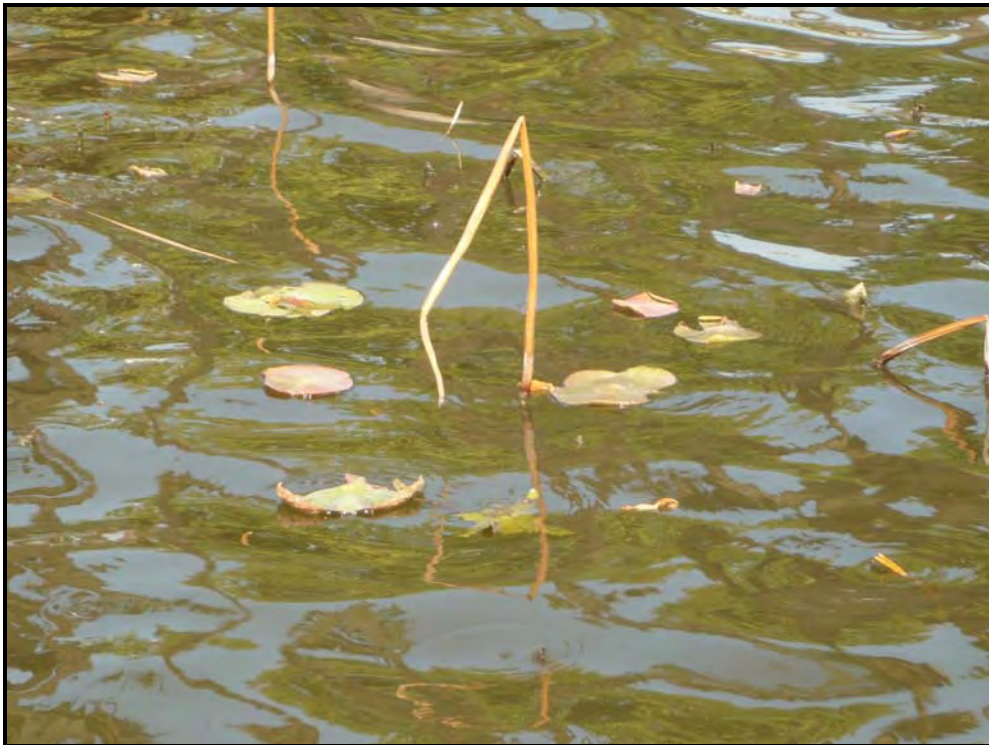
Photo 4. Lotus beds are evident by only a few stalks and leaves.

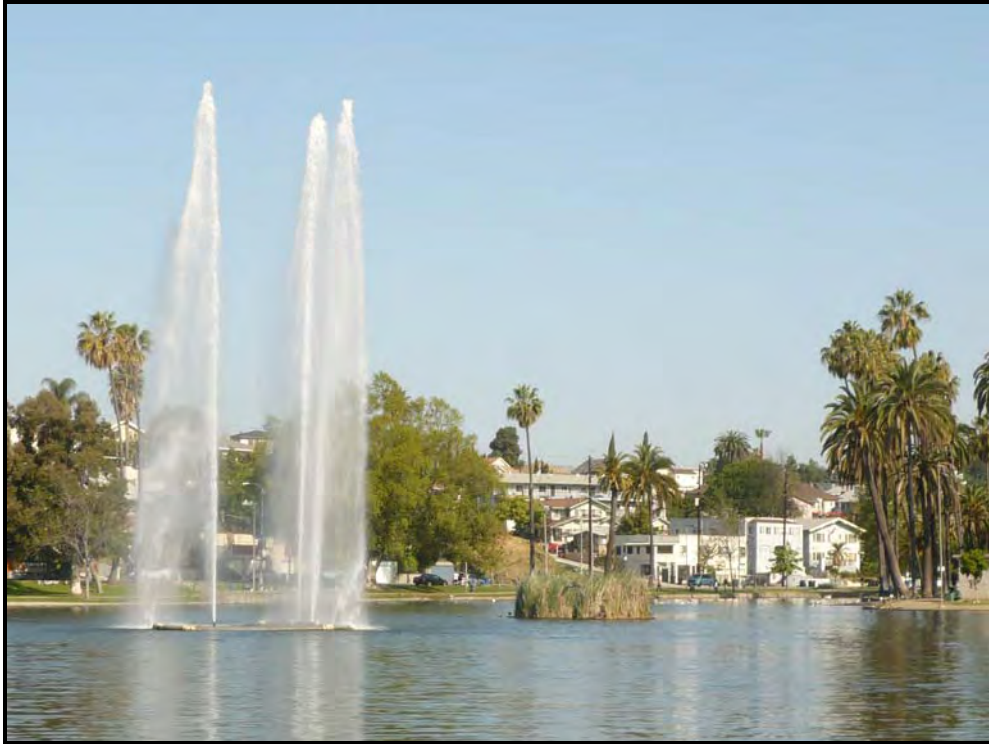
Photo 5. Northwesterly view of one of four floating wetlands. Lake bordered by mature trees, palms and grassy lawns.

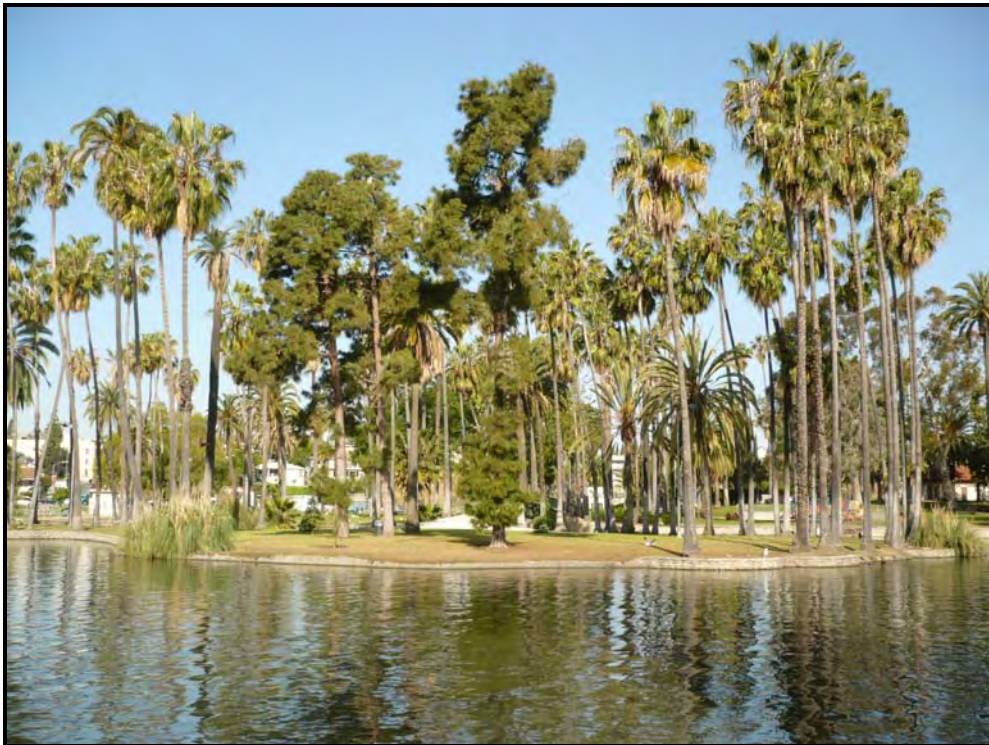
Photo 6. Westerly view. The island located in the northeastern lobe of the lake. Cattails adorn the island's perimeter. Great blue herons are nesting in the ornamental pines located at the center of the island.

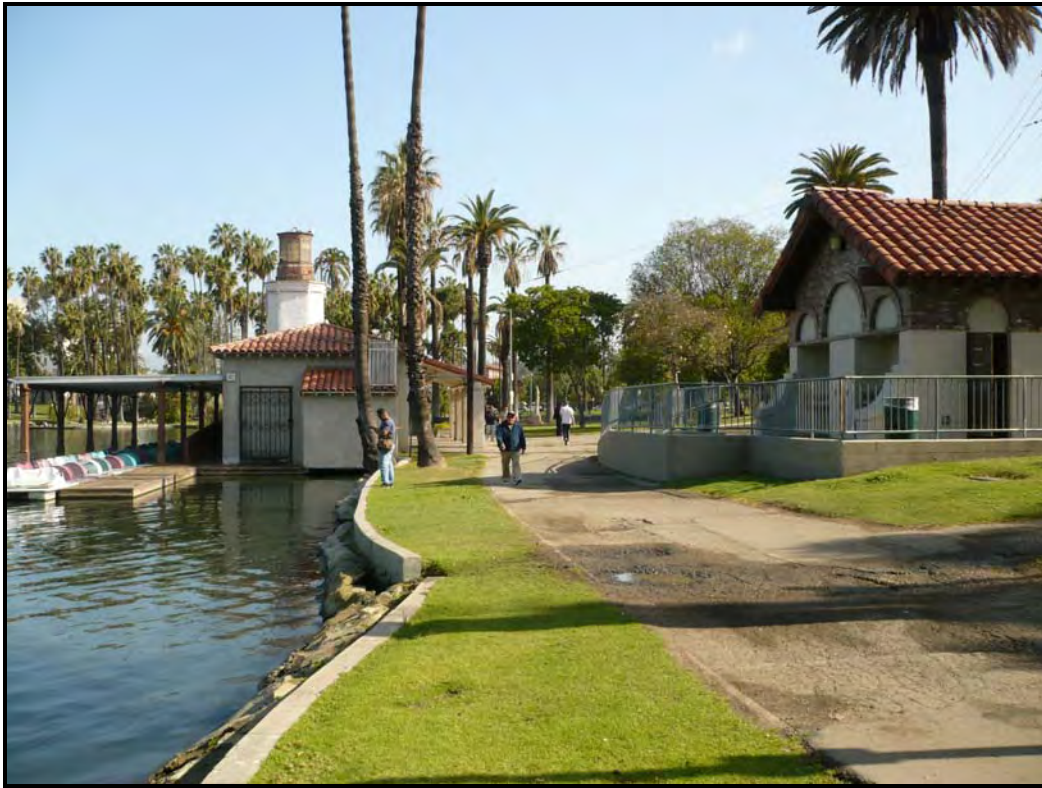
Photo 9. Northerly view. Echo Park historic boathouse and associated structures located on the west side of the lake. Grassy lawn and walking path in foreground. Ornamental trees and palms in background.

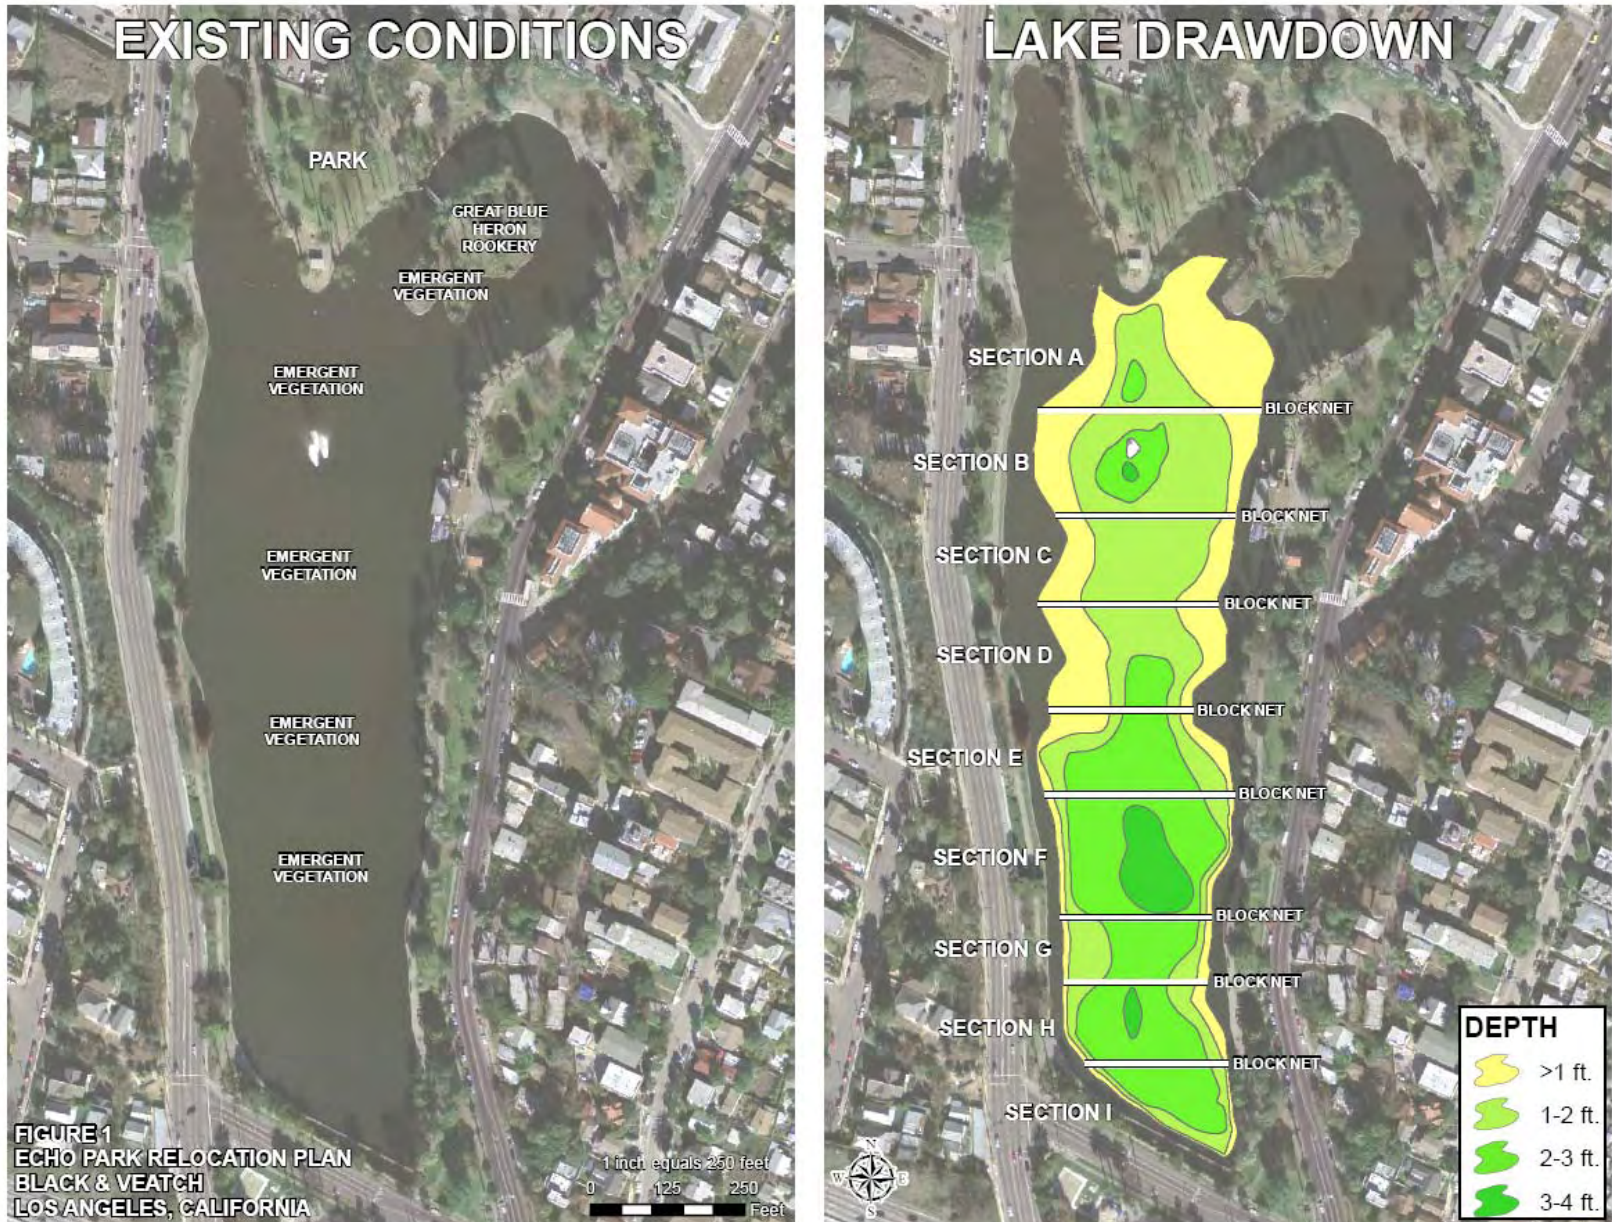
Figure 1: Existing Conditions and Lake Drawdown

FIGURE 1
 ECHO PARK RELOCATION PLAN
 BLACK & VEATCH
 LOS ANGELES, CALIFORNIA

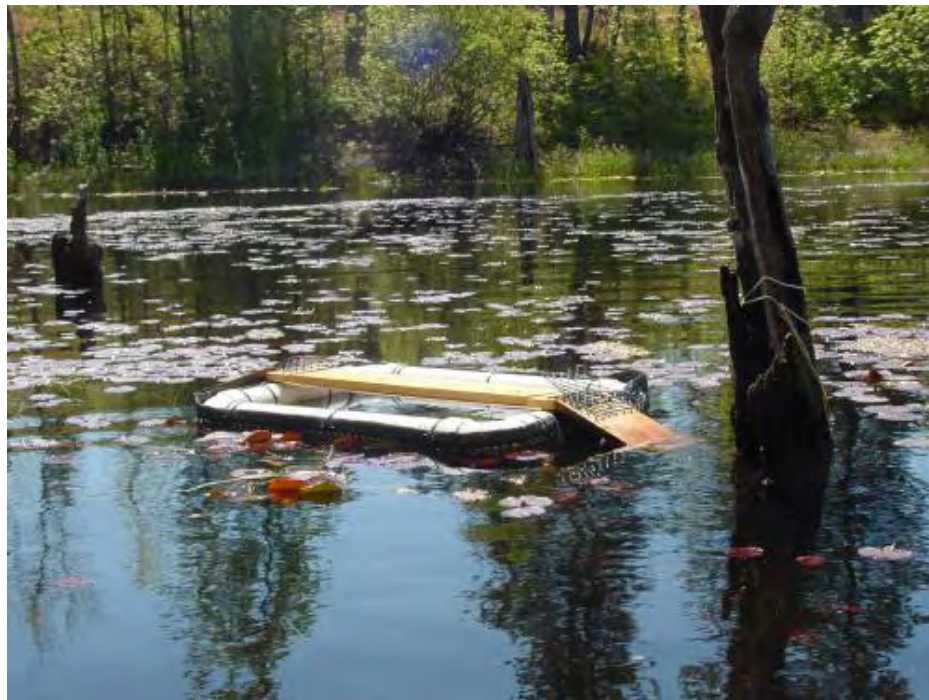
Photo 2. Another basking trap design with an internal basking board.

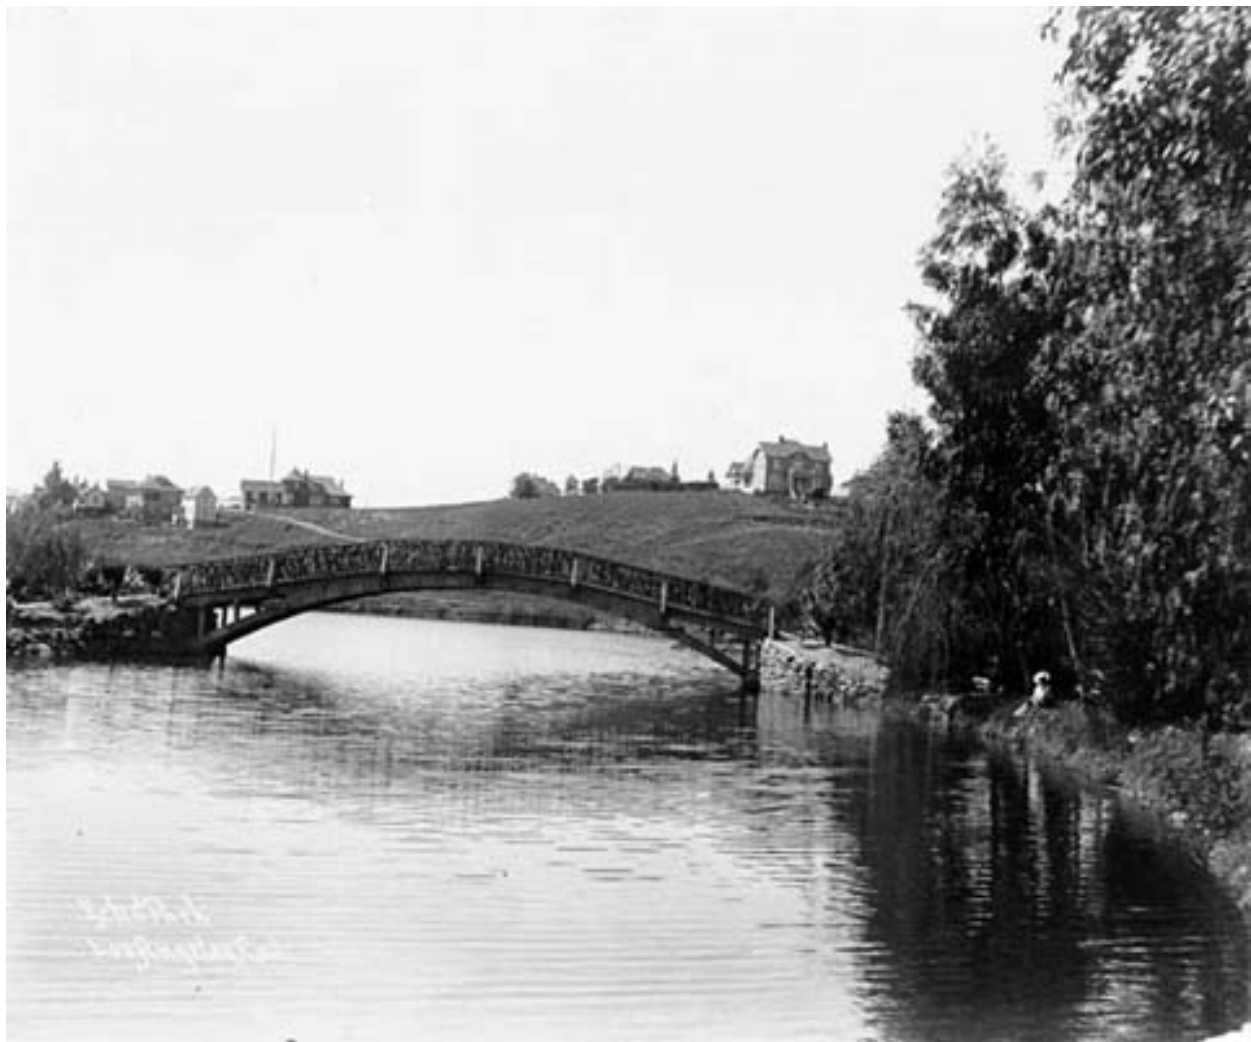
Plate 5. Original Bridge to Island, ca. 1900 (LAPL Photo Collection).

The original bridge to the island was constructed in 1895 in the same location as the present-day bridge. The bridge had a gradual arch and was made from wood with natural, rustic wooden railing (Plate 5). Its rustic style and the use of twigs in their natural state were typical of the English garden theme (Historic Resources Group 2005a).

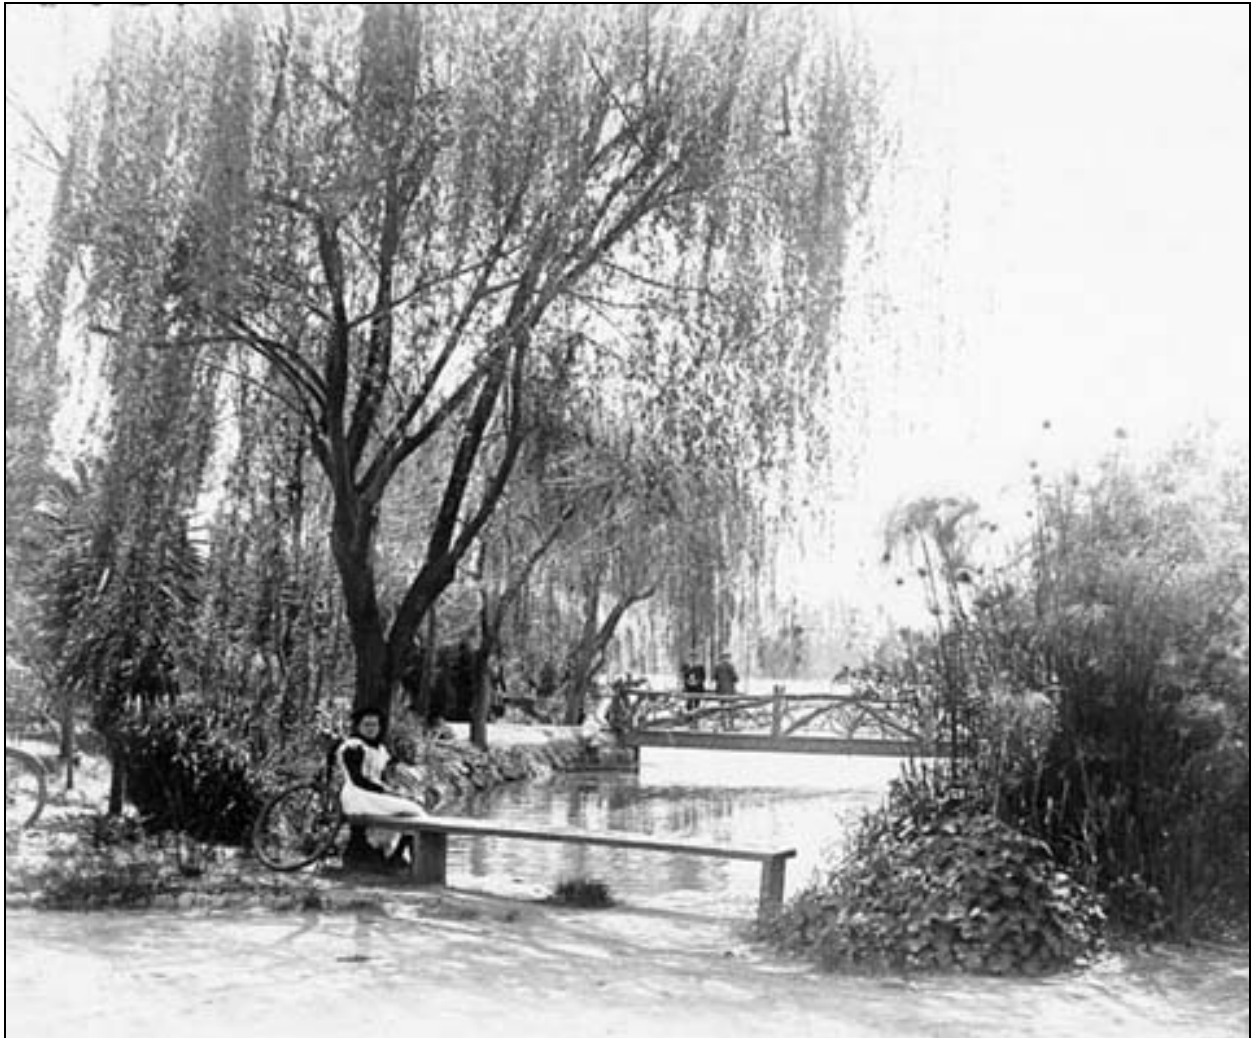
Plate 6. Flat-span Wooden Bridge in Northwestern Arm of Lake, ca. 1900 (LAPL Photo Collection).

A second bridge was once located in the northwestern lobe of the lake. It was constructed in a similar style. The wooden bridge was a flat-span bridge made of wooden planks and twig railings (Plate 6) (Historic Resources Group 2005a).

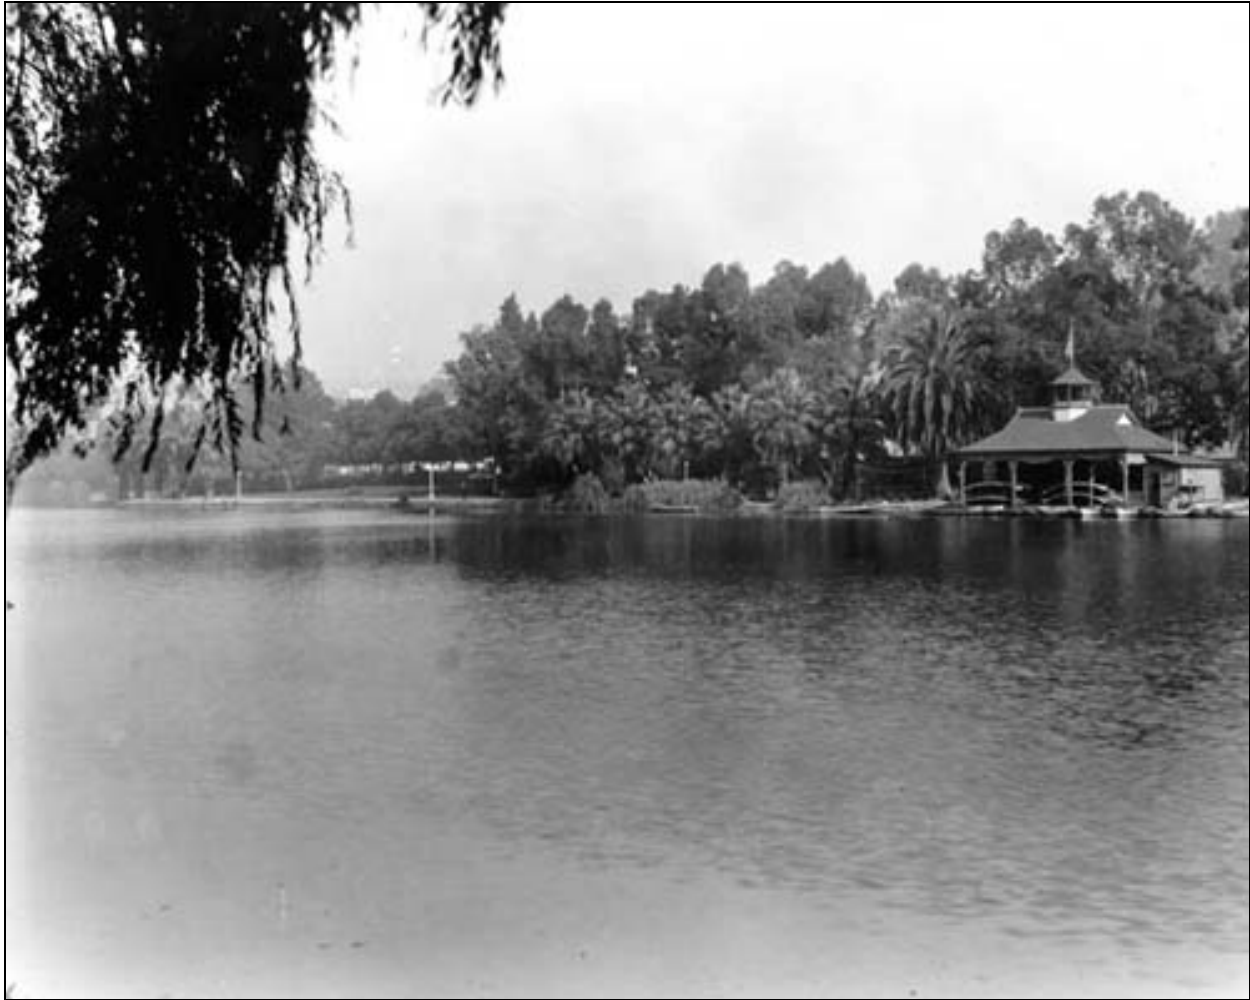
Plate 7. First Boathouse Constructed in 1895–1896 (LAPL Photo Collection).

The first boathouse opened one year later in 1896. The boathouse was constructed of wood in the Victorian style (Plate 7). It was open from 8 a.m. to 10 p.m. daily and, in addition to renting rowboats and a sailboat, park patrons could also purchase candy, nuts and lemonade from the small concession stand located within (Historic Resources Group 2005a).

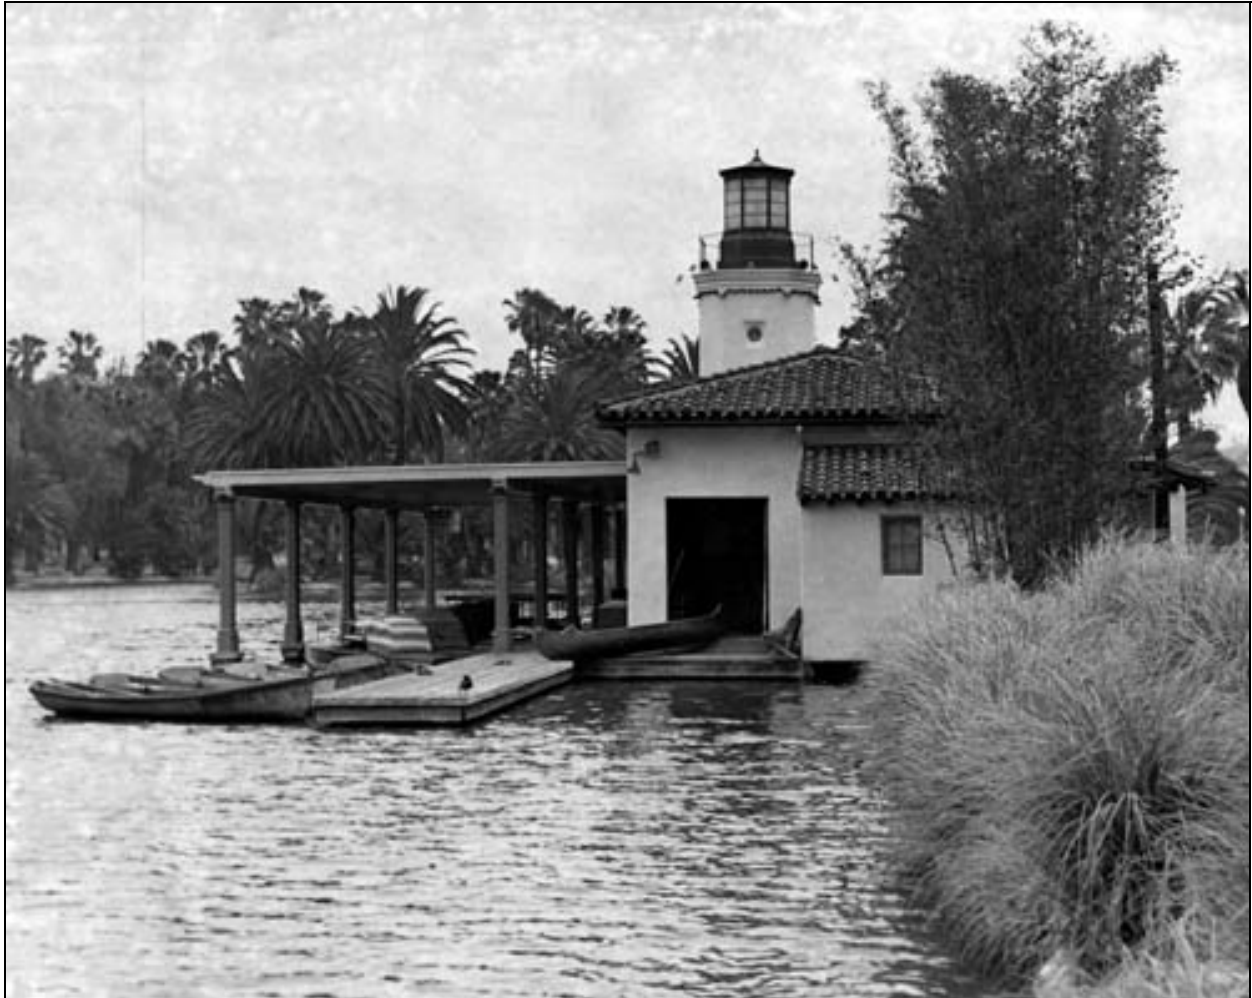
Plate 9. Existing Boathouse, ca. 1948 (LAPL Photo Collection).

during this period. The 1908 clubhouse was replaced with the existing Echo Park Recreation Center in 1925, a new boathouse (still standing) was constructed on the site of the old boathouse in 1932 (Plate 9), and the “Lady of the Lake” sculpture by Ada May Sharpless was installed in 1935 (Historic Resources Group 2005a).

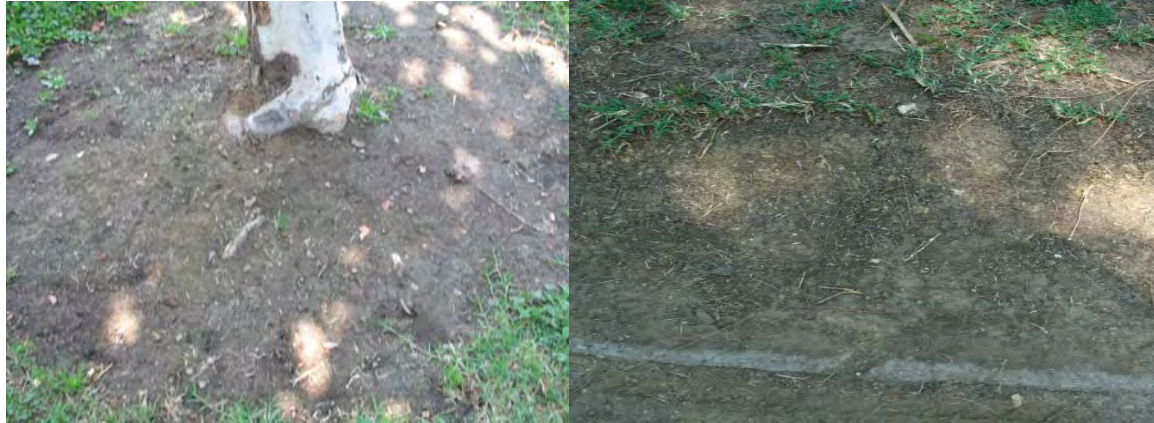
Plate 13. A Range of Soil Types Observed within the Project Area.

dark brown organic top soils to lighter brown sandy clay (Plate 13). A low vertical cut on the east side of the lake where the grass meets the pathway was also inspected. Soils observed ranged from tan to medium brown sandy clay. No cultural materials were identified during the survey.

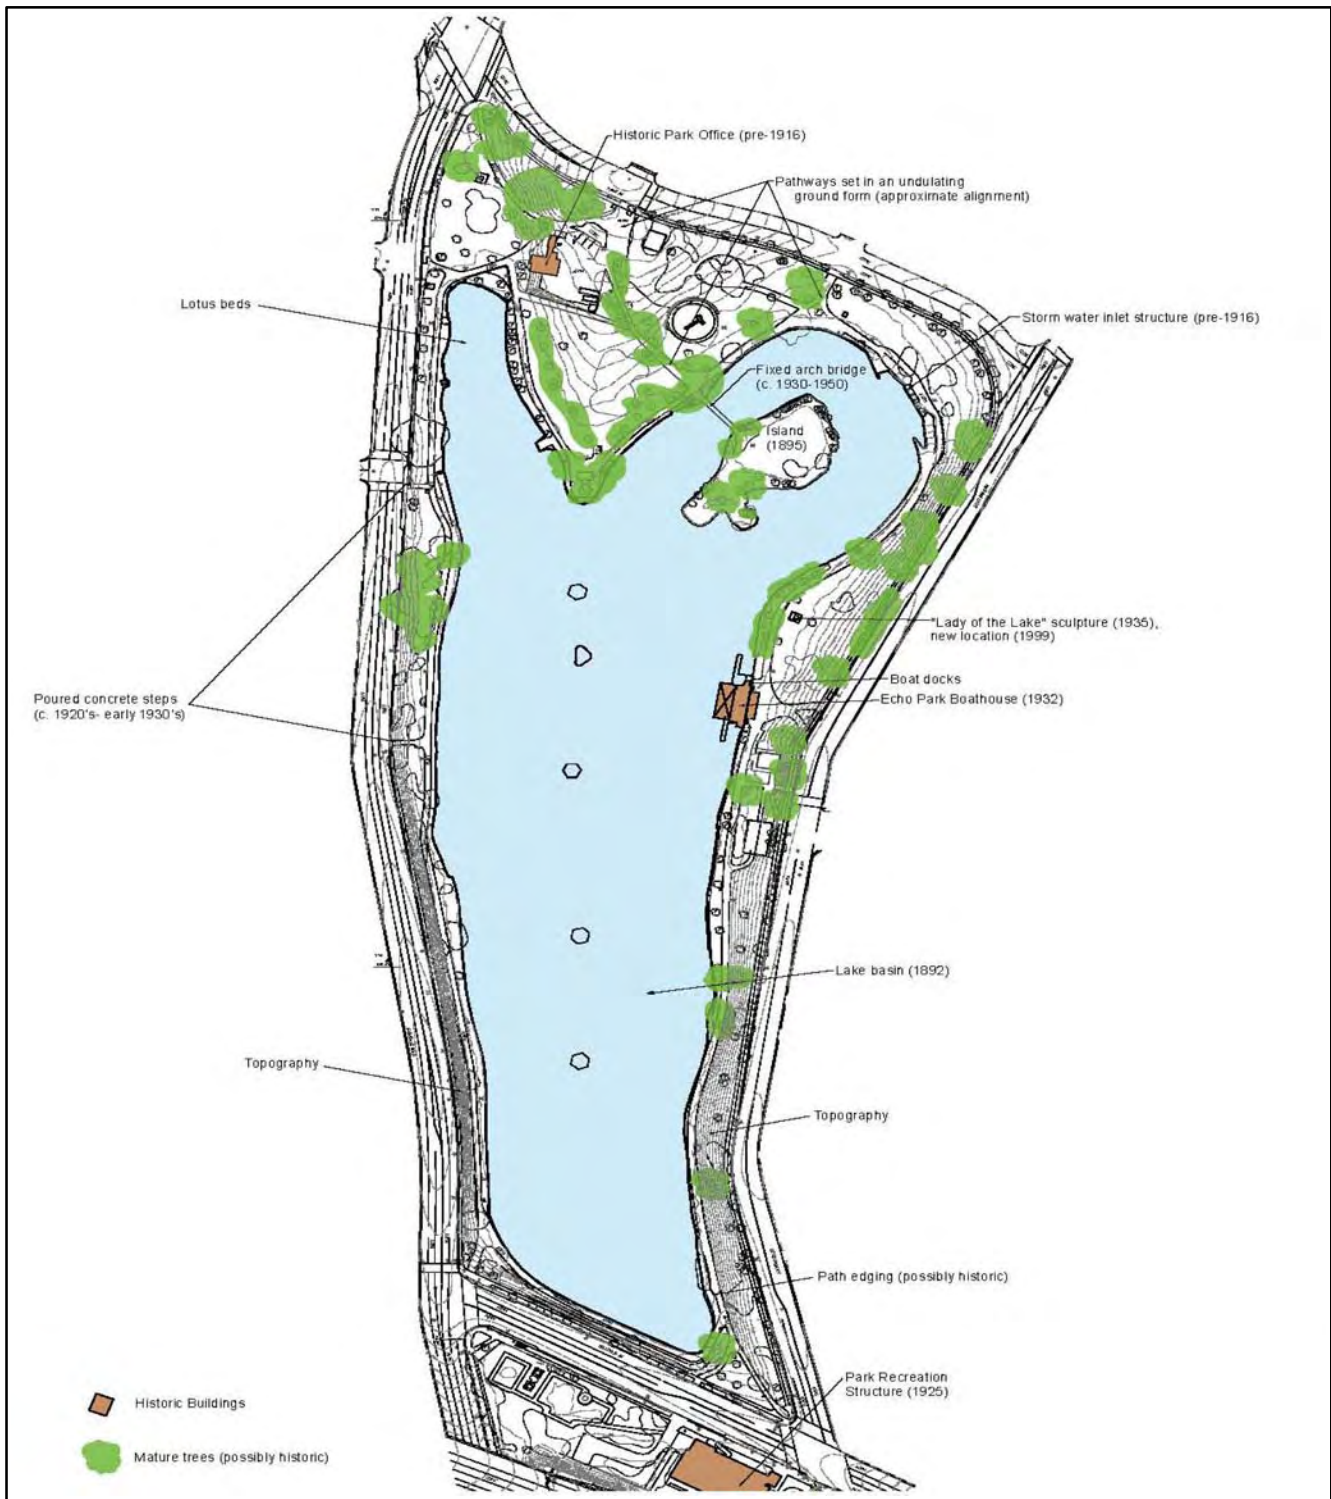
Figure 4
Existing Conditions

In order to understand the relationship between the 2008 Echo Park landscape and the historic landscape that existed during its period of significance (1870–1943), this report presents a description of existing conditions (see Figure 4). The analysis focuses on extant historic features within the Project area (see Figure 5), though known missing features are also identified. The goal of the analysis is to understand what historic features contribute to the significance of the landscape, and to provide the basis for a treatment plan for the cultural landscape. Sources such as historic photographs, maps, and aerial photographs were used to understand the character of the landscape during its period of significance. Available historic documentation of the park's physical development included early (1910s) engineering and planning maps and historic oblique aerial photographs that provide only limited information about the park's physical evolution and development. Given the documentation obtained, the analysis presented here reflects the fullest possible picture of the park's history.

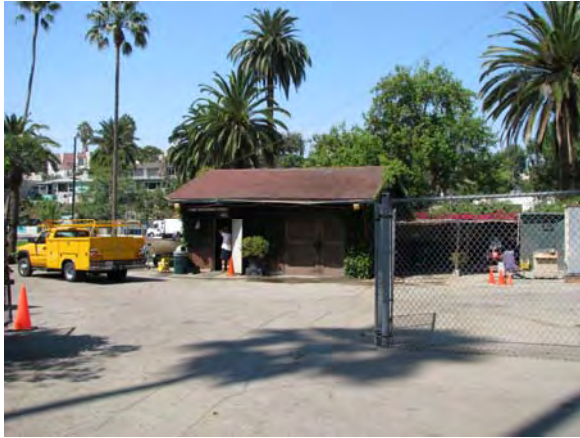
Plate 14. Park Maintenance Building (pre-1916)

Three historic buildings remain in the Echo Park landscape: the Park Maintenance Building (pre-1916) on peninsula near Park Avenue (Plate 14), the Boathouse (1932) on the east edge of the lake (Plate 15), and the Park Recreation Structure (1925) located directly adjacent the Project area to the south of Bellevue Avenue (Plate 16).

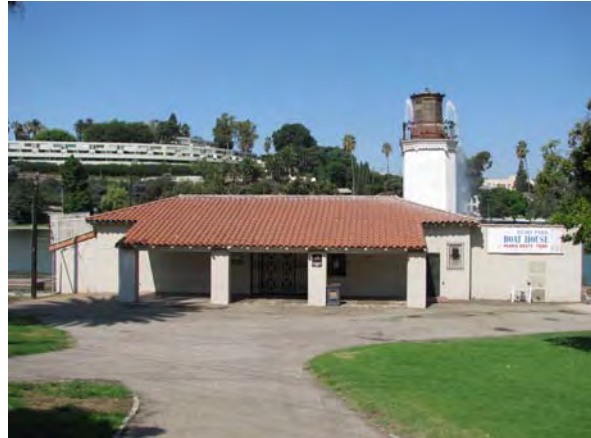
Plate 15. The Boathouse (1932)

These buildings all remain from the period of significance, and the Boathouse and Park Recreation Structure reflect the significance of the Spanish Colonial Revival architecture theme through characteristics such as their stucco or brick cladding and tiled roofs. These buildings include small additions, such as a new accessibility ramp at the Park Recreation Structure, and the Boathouse has minor new additions of fencing/railing on its roof. The Park Office Building, a small, ivy-covered, brick maintenance building with a small shed addition, appears to have a new set of concrete steps on its west side. Missing historic buildings include the original Victorian boat house and earlier restroom buildings.

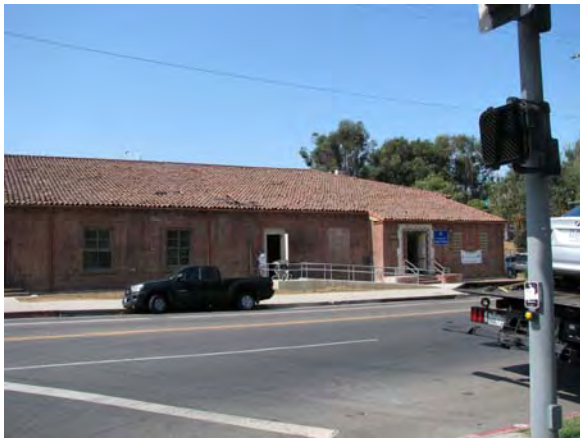
Plate 16. The Park Recreation Structure (1925)

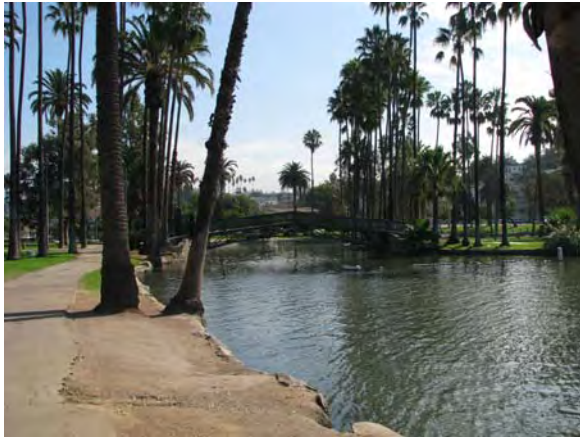
Plate 21. Bridge to Island with Bridge Abutments (c. 1930–1950)

island and shore up the peninsula edges. The boat docks at the Boathouse may survive from the historic period as well (Plate 22). One stormwater inlet also appears to survive from the historic period (Plate 23). Missing structures include two historic bridges: one that occupied the location of the existing bridge, and one in the northwestern lobe of the lake crossing the lotus bed area.

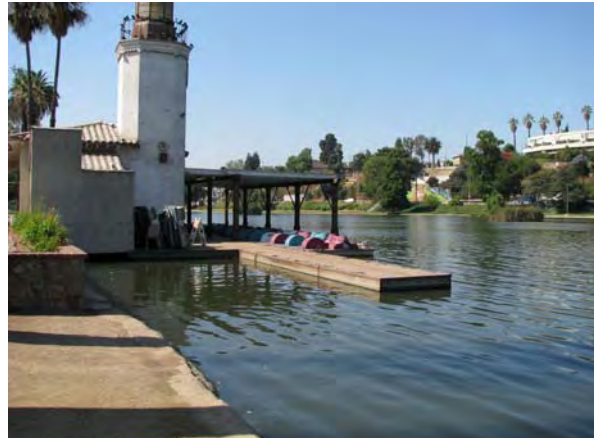
Plate 22. Boat Docks at Boathouse

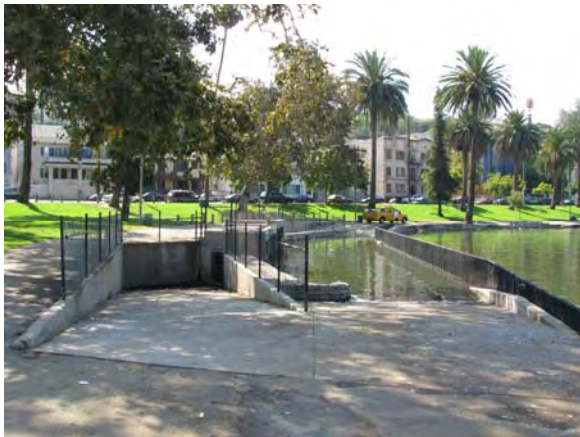
Plate 23. Stormwater Inlet Structure

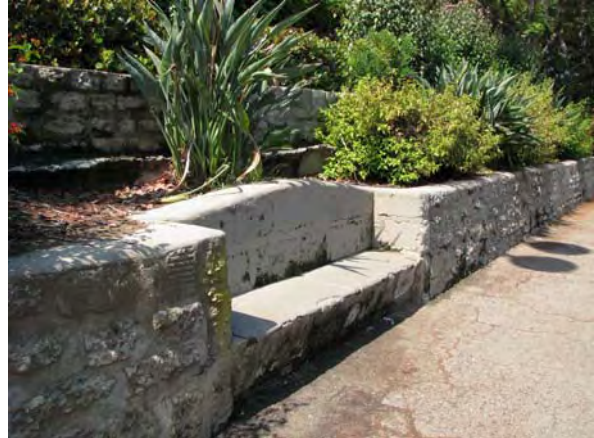
Plate 25. Masonry Retaining Walls with Three Built-in Benches

Many additional structures have been added to the park since the 1940s. These include recreational structures such as the new circular play area on the peninsula (Plate 24), masonry retaining walls with built-in benches (Plate 25), four constructed floating wetlands (Plate 26), a storm water infrastructure inlet (Plate 27), sections of retaining wall/lake edge (Plate 28), the retaining walls near the Boathouse restroom (Plate 29).

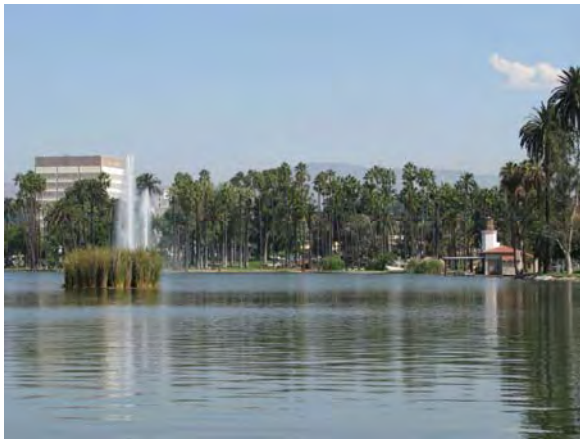
Plate 26. Constructed Floating Wetlands (4)

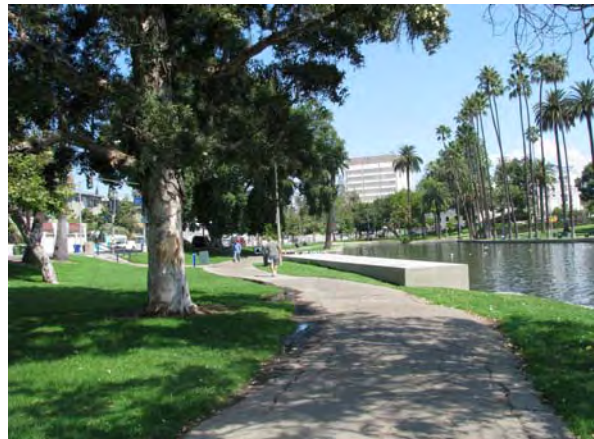
Plate 27. Storm Water Infrastructure Inlet

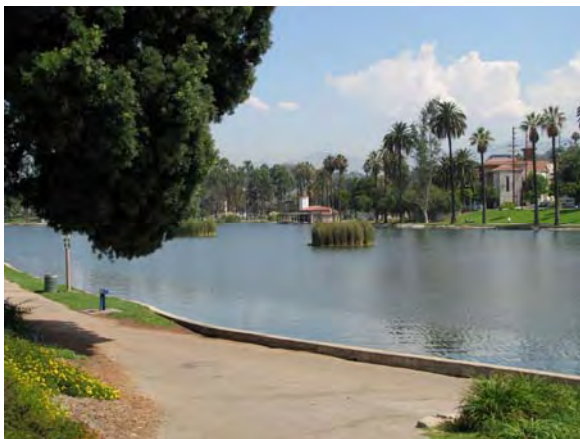
Plate 28. Retaining Wall/Lake Edge

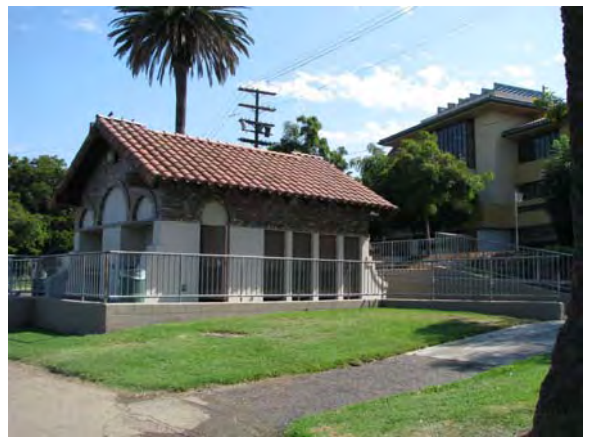
Plate 29. Retaining Walls Near Boathouse Restroom

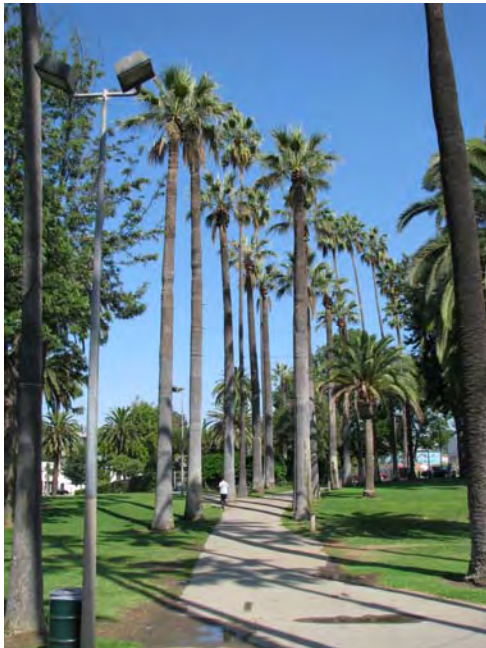
Plate 30. Path Sections on Peninsula

Surviving historic circulation systems include the approximate alignments of the pathways that encircle the lake and provide access to the peninsula. These paths remain in their approximate locations from the 1910s (Plates 30–32). The historic materials of the path system may have included crushed stone, sand, soil, and later, asphalt and concrete. In addition, two concrete stairways (Plate 33) installed along the sidewalk at Glendale Boulevard also survive from the historic period (one additional original stairway appears to have been reconstructed in place). Missing historic circulation systems include pathways around the island, and pathways in other locations such as at the former location of the first historic Boathouse.

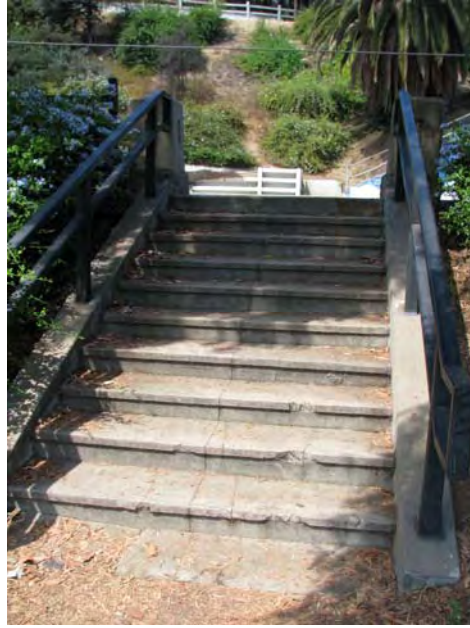
Plate 33. Concrete Steps from Street-level Pathway to Park-level Pathway (1920s-early 1930s)

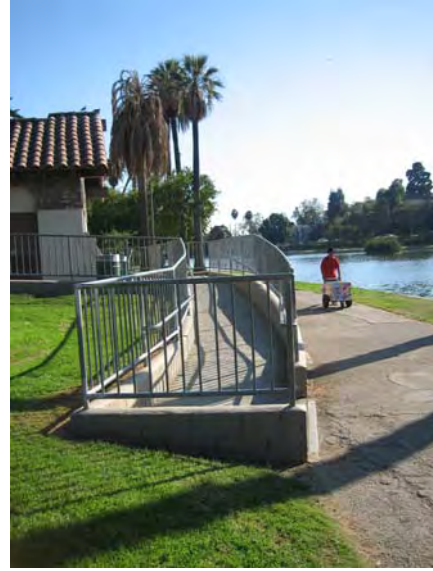
Plate 39. Ramps near Boathouse Restrooms

There have been changes and additions to the circulation system at the park since the period of significance including the addition of the parking and maintenance area at the office building; new park entrance locations (such as the entrances near the Boathouse, at the corner of Echo Park and Bellevue Avenues, and near the north end of the park at Glendale Boulevard); street-level sidewalks at Echo Park Avenue and Glendale Boulevard; and some sections of pathways on the peninsula. (Plates 34–39).

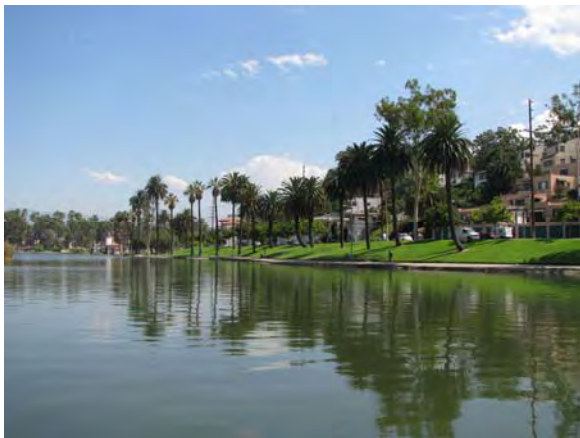
The most important feature of the park is the lake (Plate 48), which survives from the late 1870s when it was still a reservoir. The reservoir was modified during the site's creation as a park, though the lake continues to serve as a retarding basin for the city's storm water system. The precise configuration of the lake edge has changed, although the lake's outline remains much as it did over the last century. One section of the lake—its northwestern lobe—was partially filled in, and no longer remains as a water feature. Another historic water feature that is now missing is a small fountain formerly located south of the concrete block utility shed along the east side of the park.

Plate 48. Lake (1892)

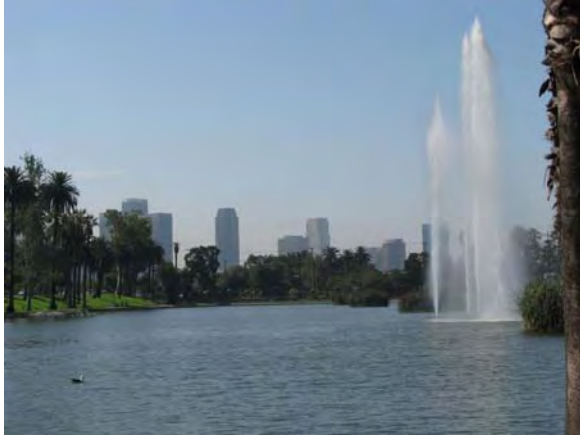
The large fountain in the northern half of the lake is a relatively new feature, reported to have been installed in the early 1980s as part of Los Angeles' hosting of the 1984 Olympic Games (Plate 49).

Plate 49. Fountain

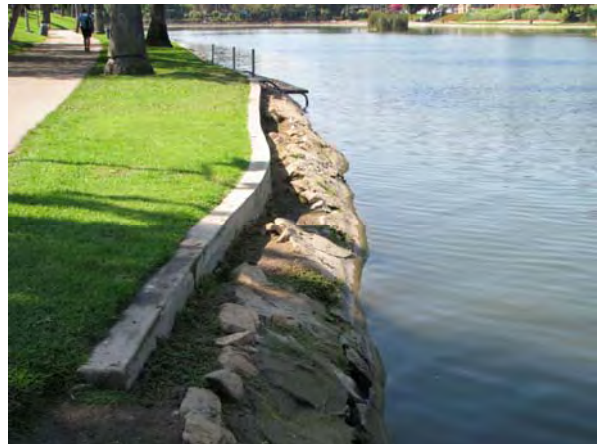
Plate 65. Sections of Exposed Riprap that May Survive from the 1890s

The topography at Echo Park appears to have remained remarkably intact to at least the 1910s; the original bowl-shaped lake bed, the embankments to the streets above, and the undulating groundplane at the northern end of the park still exist today. The constructed island, created from dredged soil and stones brought from Elysian Park, has had small sections of land added on its northern side. The original constructed lake edge, with its rip-rap walls, may also survive in some places. The northwestern lobe of the lake, north of the lotus bed, has been filled in to reduce the lake footprint. Additionally, some modification to the lakes southern edge may also have occurred. (Plates 64–68).
