EDAW, Inc. was contracted by Black & Veatch to conduct a reconnaissance survey and impact analysis report for the Echo Park Rehabilitation Project. The City of Los Angeles (City) is proposing to rehabilitate Echo Park Lake through in-lake basin improvements, in-lake vegetation and habitat improvements, and parkland structural best management practices (BMPs), including grassy swales/infiltration strips, porous pavement, “SMART” irrigation system, and educational signage and kiosks. Potential impacts to biological resources from construction and operations associated with this project are discussed herein.

Echo Park is a 29-acre open-space recreational facility located at 751 Echo Park Avenue, in the Echo Park/Silverlake community of Los Angeles, California. The park is bounded to the north by Park Avenue, to the east by Echo Park Avenue, to the south by Bellevue Avenue, and to the west by Glendale Boulevard (Figures 1 and 2). Of the 29-acre park, Echo Park Lake occupies 13 acres while the remaining 16 acres contains recreational open space.

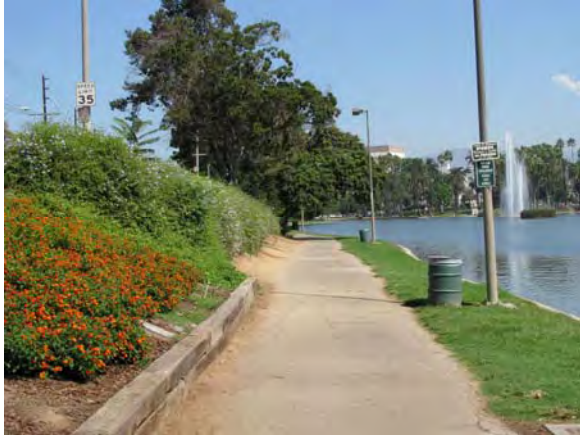
Plate 66. Embankment on Park Edges near Glendale Boulevard and Echo Park Avenue

The topography at Echo Park appears to have remained remarkably intact to at least the 1910s; the original bowl-shaped lake bed, the embankments to the streets above, and the undulating groundplane at the northern end of the park still exist today. The constructed island, created from dredged soil and stones brought from Elysian Park, has had small sections of land added on its northern side. The original constructed lake edge, with its rip-rap walls, may also survive in some places. The northwestern lobe of the lake, north of the lotus bed, has been filled in to reduce the lake footprint. Additionally, some modification to the lakes southern edge may also have occurred. (Plates 64–68).

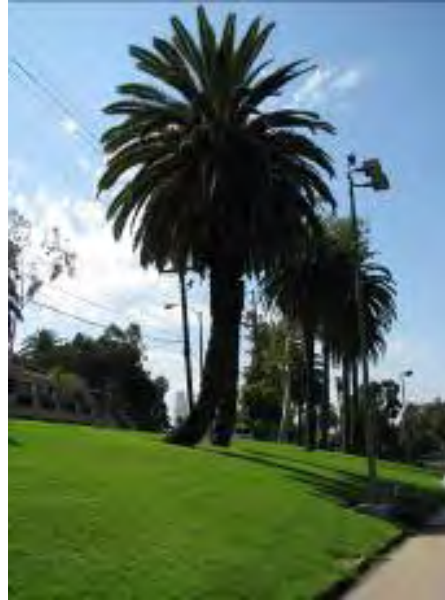
Plate 67. Embankment on Park Edges near Glendale Boulevard and Echo Park Avenue

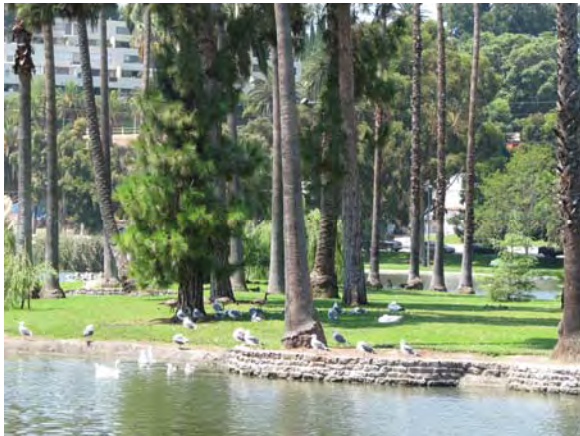
Plate 68. Island, Surviving from 1895

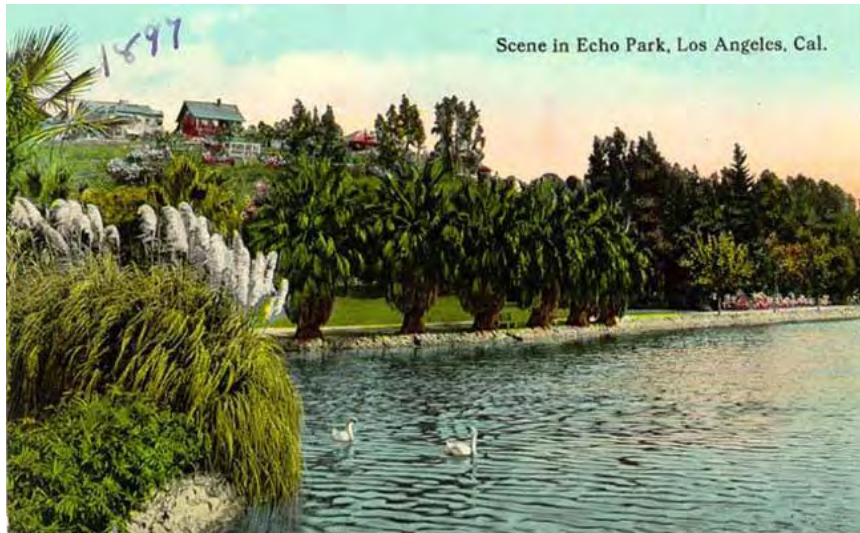
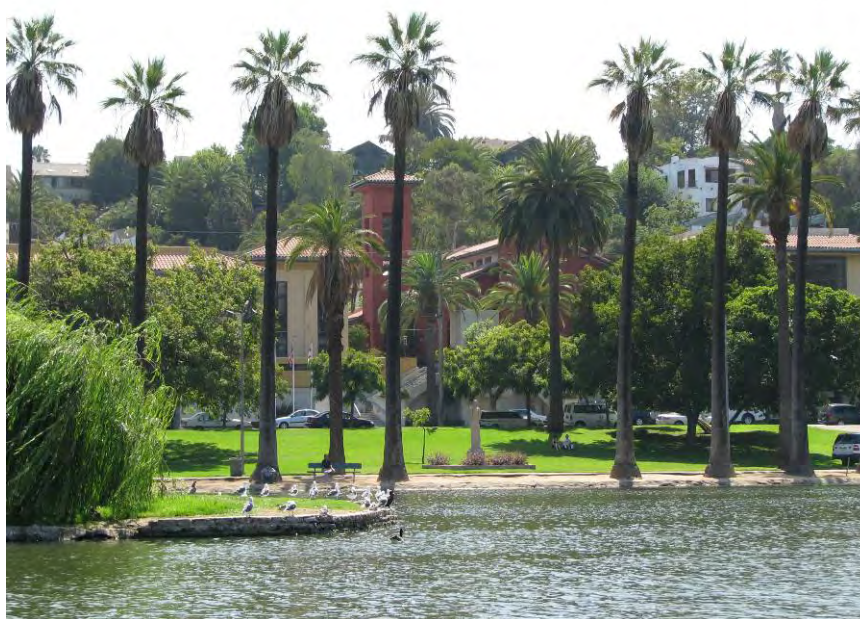
Some island vegetation—ornamental grasses—and the palms that line the lake edge on its eastern side may remain from the period of significance. Though the palm trees in the existing conditions photograph appear to be the same trees shown in the historic photograph (1897), their growth has changed the spatial quality of the landscape (Plates 69 and 70).

Plate 69. Historic Photograph (1897)

Plate 70. Modern Photograph (2008)

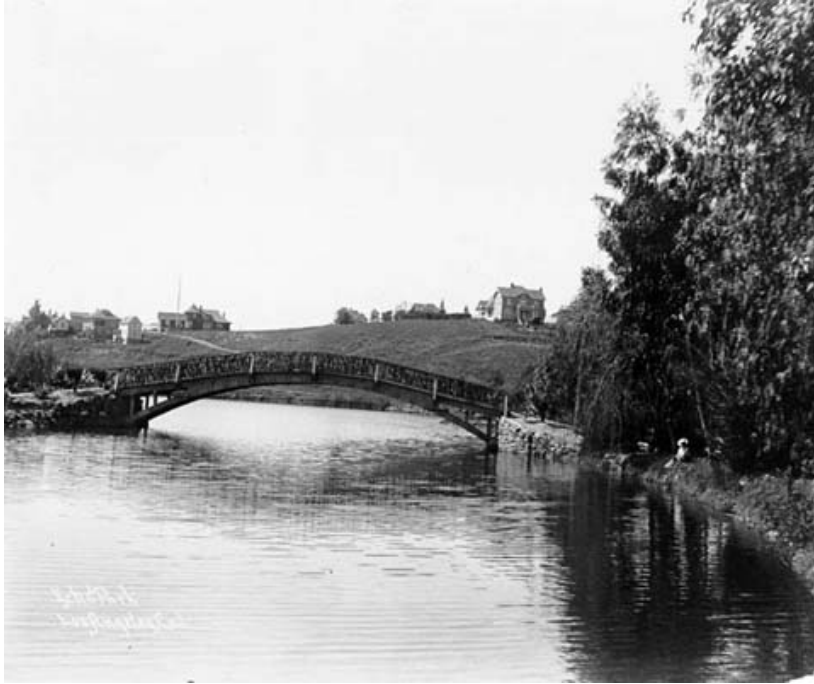
Plate 71. Historic Photograph (c. 1900)

These photographs show both of the bridges that have connected the island to the peninsula. The historic photograph (c. 1900) shows the original bridge, built in 1895, with its rustic character and arch. The bridge in the existing conditions photograph shows the second bridge, constructed sometime between 1930 and 1950 (Plates 71 and 72).

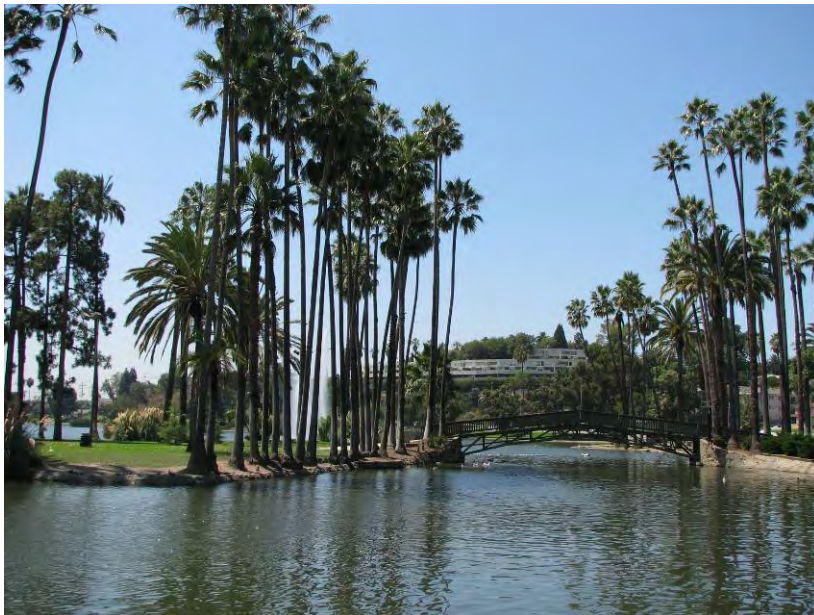
Plate 72. Modern Photograph (2008)

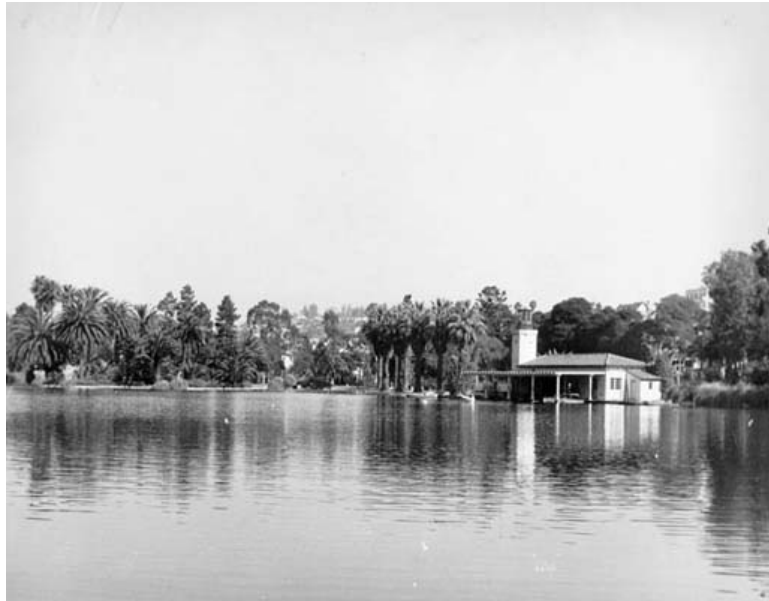
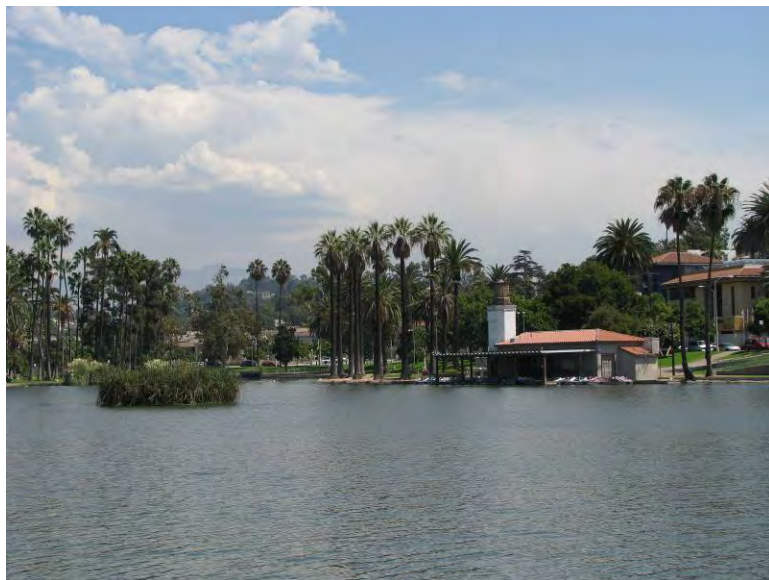
The Boathouse shown in these photographs has remained intact since the period of significance. Many of the trees in the historic photograph (1937) also remain, although some of the understory vegetation is now missing. The lake has also remained the same, with minor additions of the floating wetlands visible in the existing conditions photograph (Plates 73 and 74).

Plate 73. Historic Photograph (1937)

Plate 74. Modern Photograph (2008)

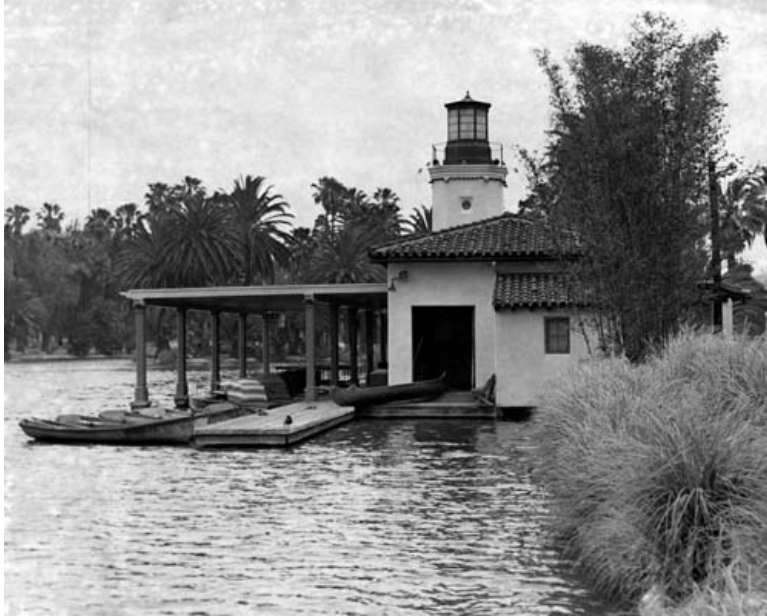
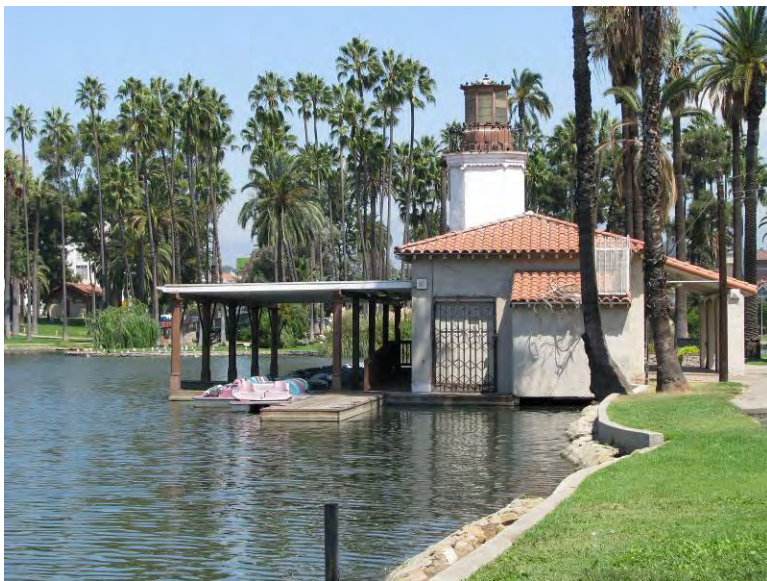
These photographs of the Boathouse demonstrate some minor changes to the Boathouse and its environs—the loss of windows and a door, and the loss of low vegetation such as the ornamental grasses that lined the lake edge. However, the palm trees in the background seem to remain from the historic period (Plates 75 and 76).

Plate 75. Historic Photograph

Plate 76. Modern Photograph (2008)

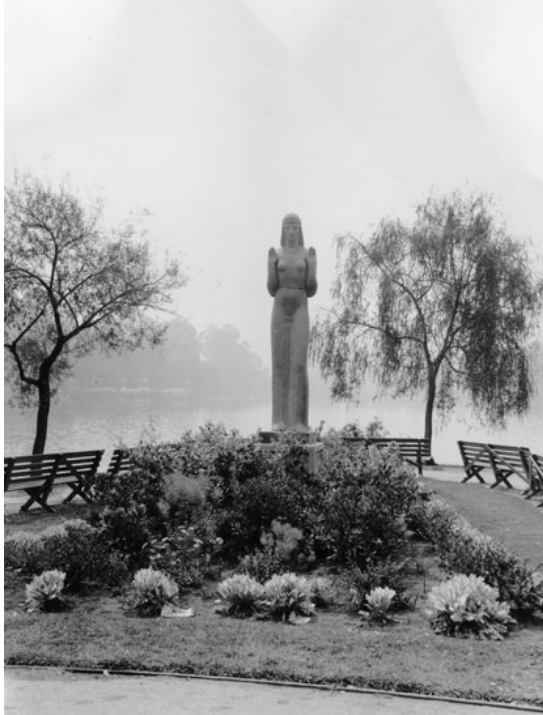
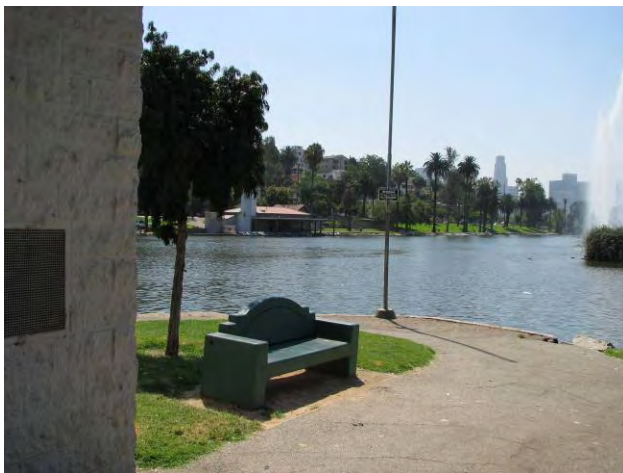
The tip of the peninsula has changed substantially since the period of significance. The Lady of the Lake, willows and ornamental plantings, the configuration of the original benches, and the alignment of the paths shown in the historic photograph (1937) are now missing from this location. However, with the removal of the pump house it would be possible to reverse the current condition to its historic appearance (Plates 77 and 78).

Plate 77. Historic Photograph (1937)

Plate 78. Modern Photograph (2008)

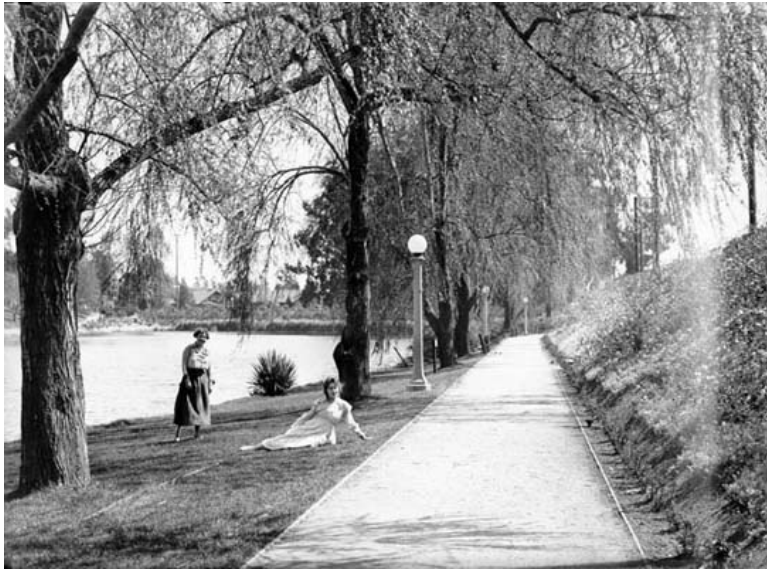
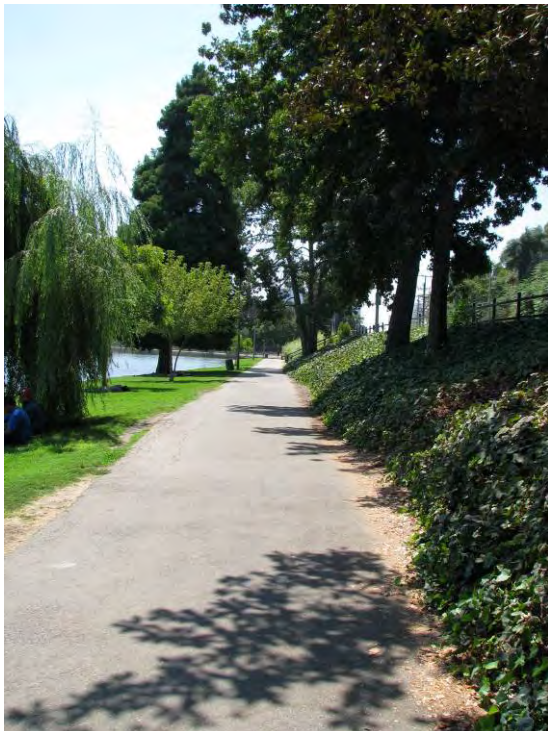
The pathway along Glendale Boulevard retains its long, straight character shown in the historic photograph (circa 1910s). It is tree-lined for much of its length, and retains the grade separation between the lake and road above (Plates 79 and 80).

Plate 79. Historic Photograph (1910s)

Plate 80. Modern Photograph (2008)

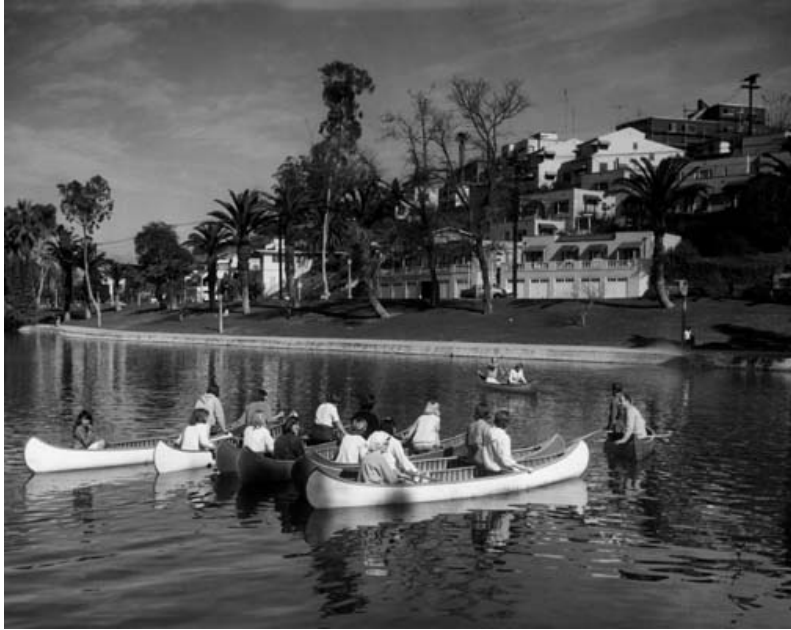
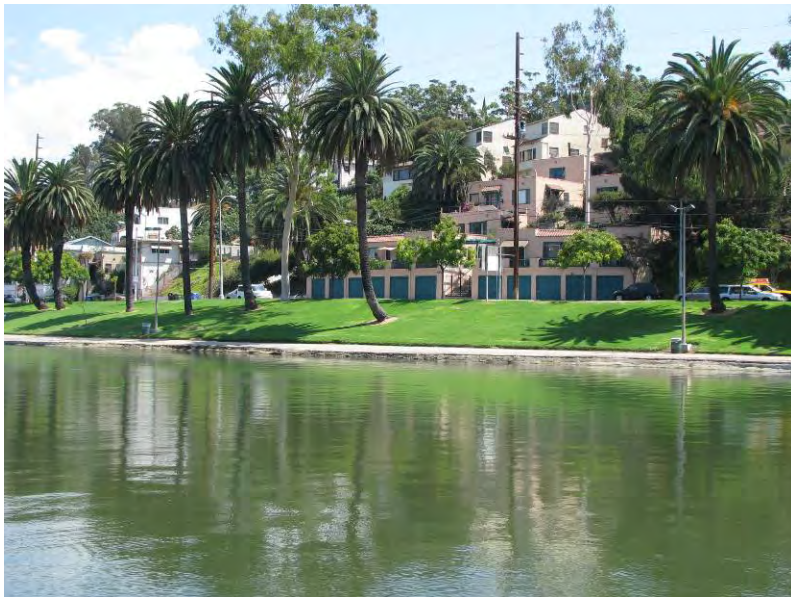
The historic photograph shown above was taken in 1965, when most of the understory vegetation had already been removed from the park or had died without being replaced. However, the grade change between the lake and the street above remain the same, as does the character of the setting of the park (Plates 81 and 82).

Plate 81. Historic Photograph (1965)

Plate 82. Modern Photograph (2008)

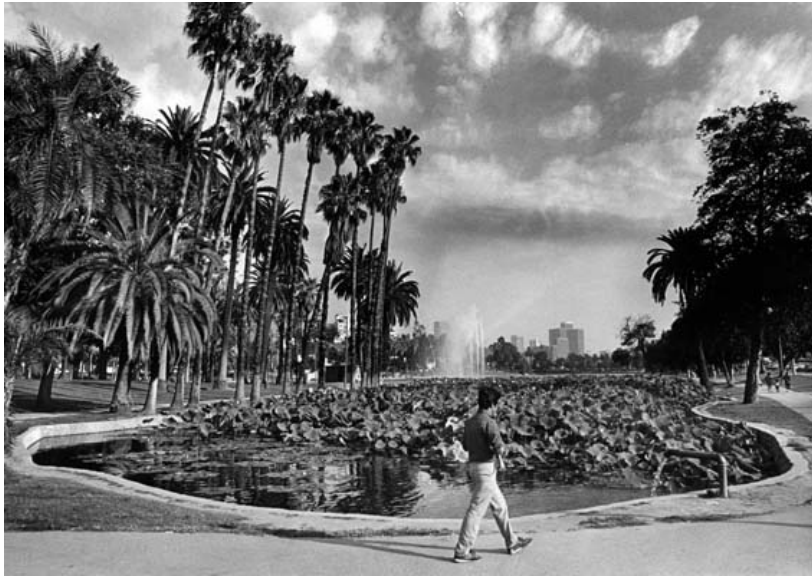
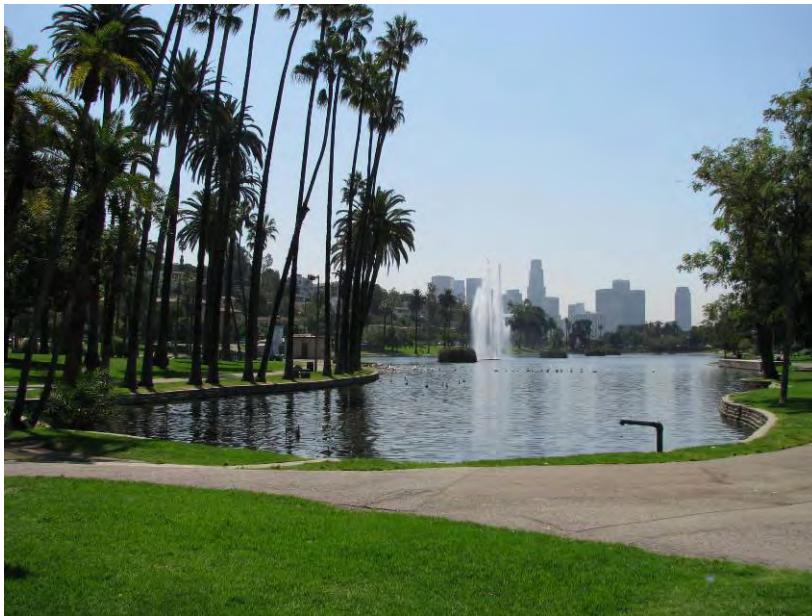
The lotus plants, in their full glory above (1988), have all but disappeared now. Other vegetation, such as the palms, remain to frame the important long views south across the lake (Plates 83 and 84).

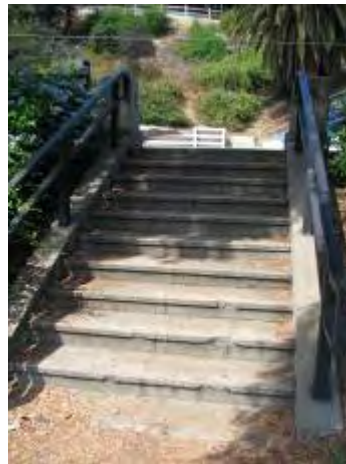
Concrete Steps from Street-level Pathway to Park-level Pathway (1920s-early 1930s)

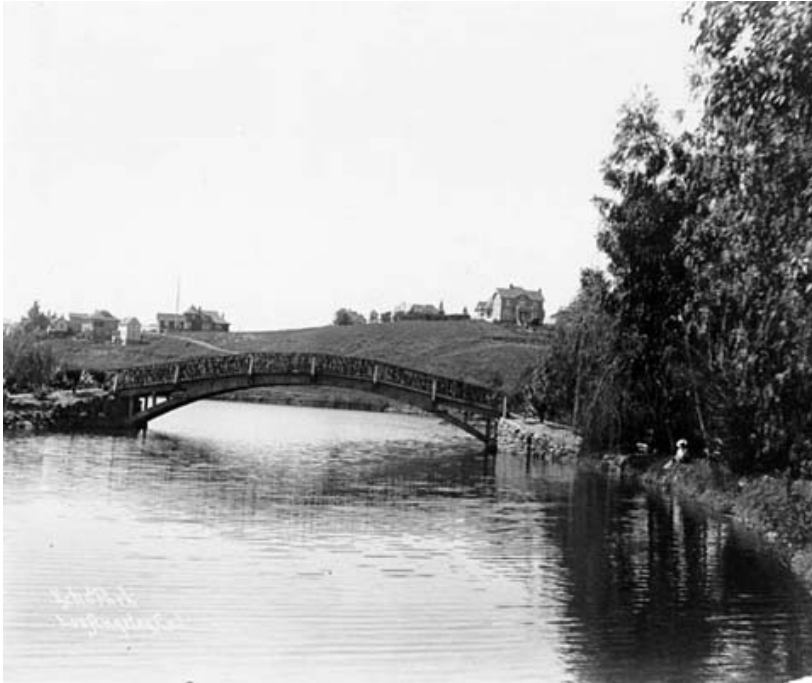
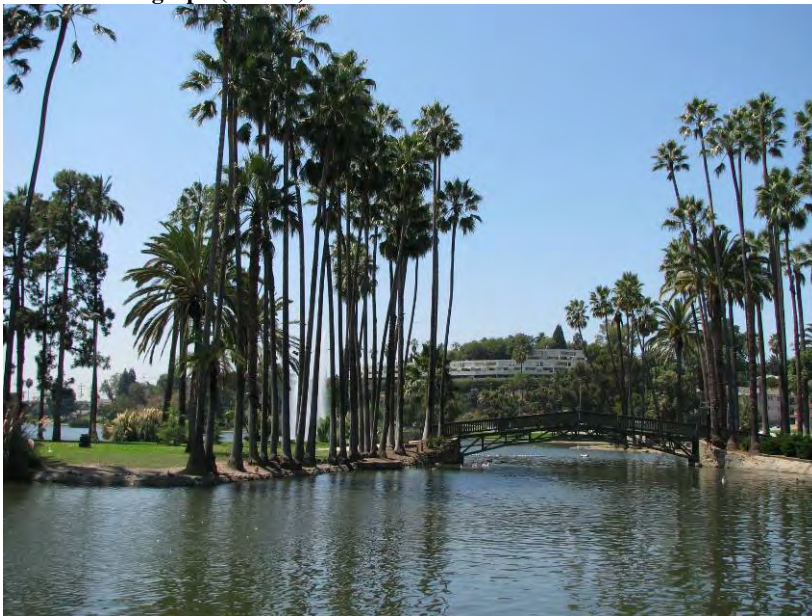
These photographs show both of the bridges that have connected the island to the peninsula. The historic photograph (c. 1900) shows the original bridge, built in 1895, with its rustic character and arch. The bridge in the existing conditions photograph shows the second bridge, constructed sometime between 1930 and 1950.

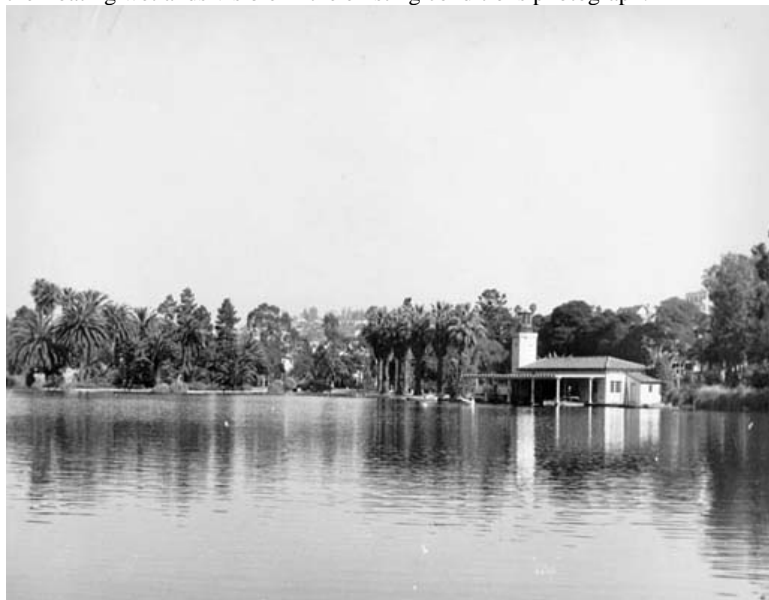
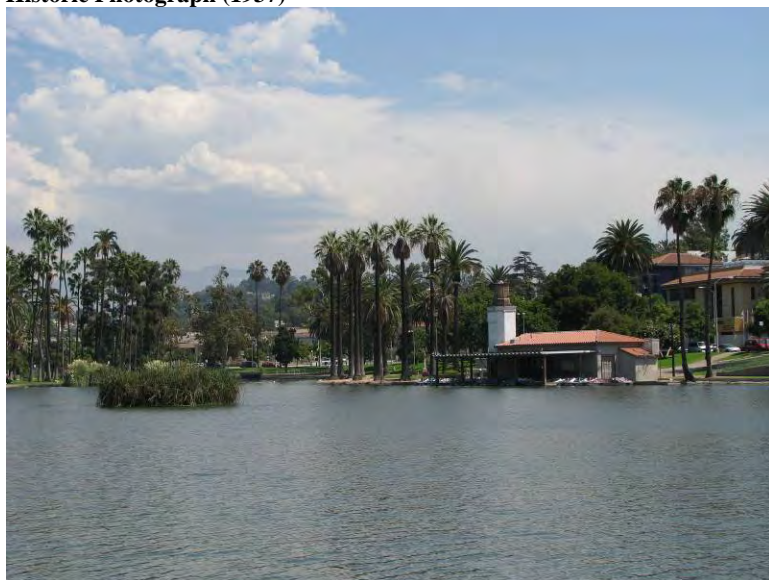
The Boathouse shown in these photographs has remained intact since the period of significance. Many of the trees in the historic photograph (1937) also remain, although some of the understory vegetation is now missing. The lake has also remained the same, with minor additions of the floating wetlands visible in the existing conditions photograph.

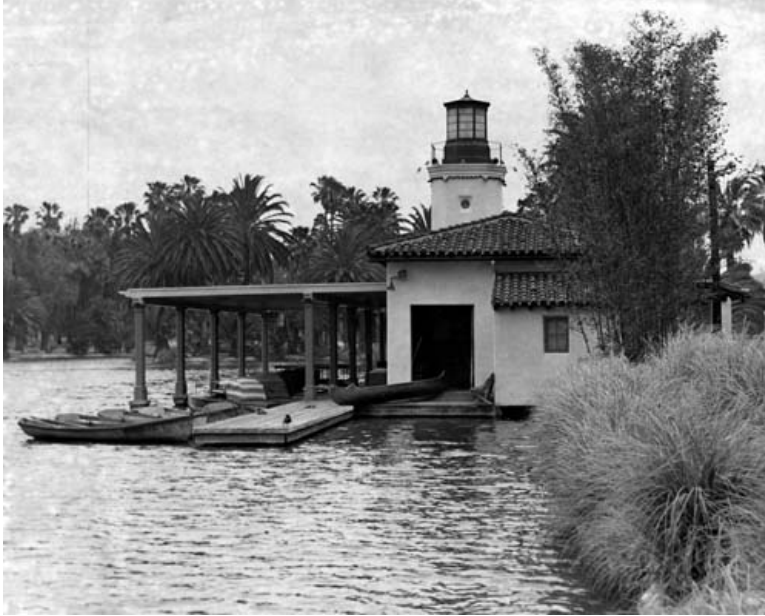
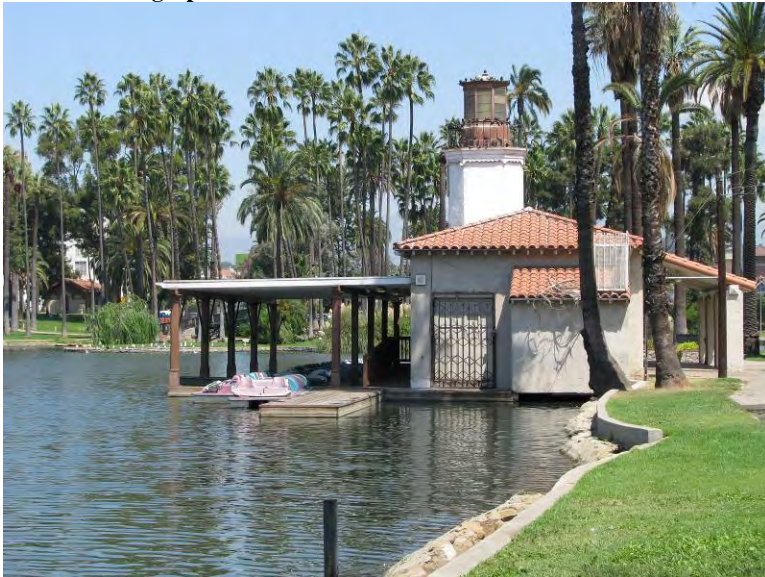
These photographs of the Boathouse demonstrate some minor changes to the Boathouse and its environs—the loss of windows and a door, and the loss of low vegetation such as the ornamental grasses that lined the lake edge. However, the palm trees in the background seem to remain from the historic period.

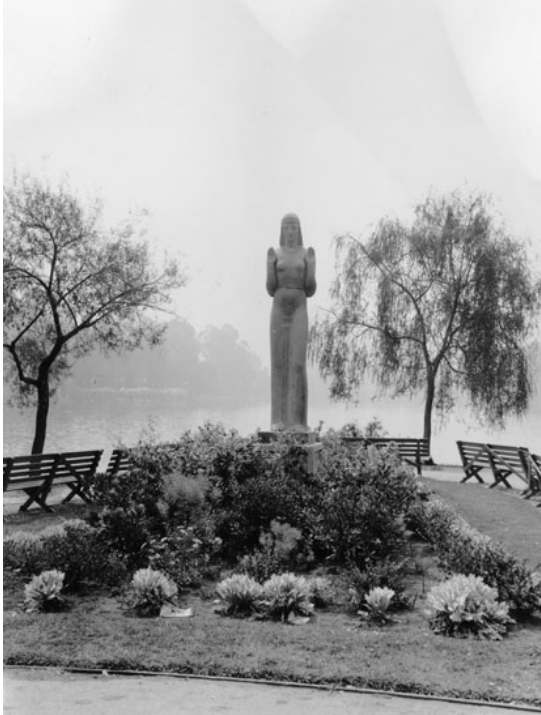
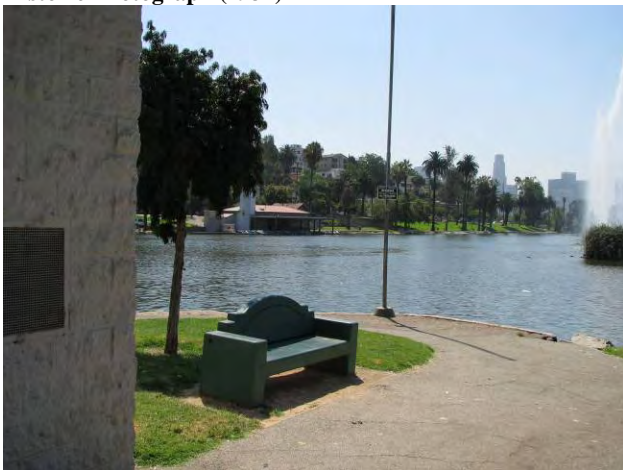
The tip of the peninsula has changed substantially since the period of significance. The Lady of the Lake, willows and ornamental plantings, the configuration of the original benches, and the alignment of the paths shown in the historic photograph (1937) are now missing from this location. However, with the removal of the pump house it would be possible to reverse the current condition to its historic appearance.

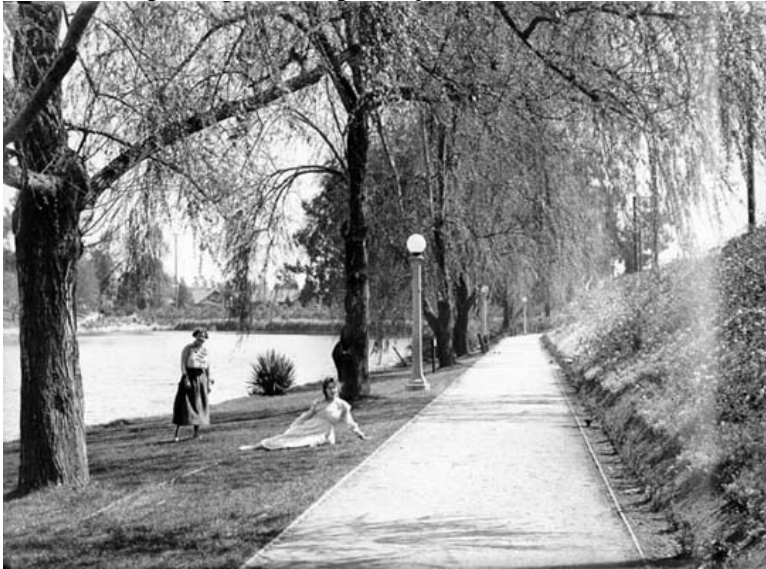
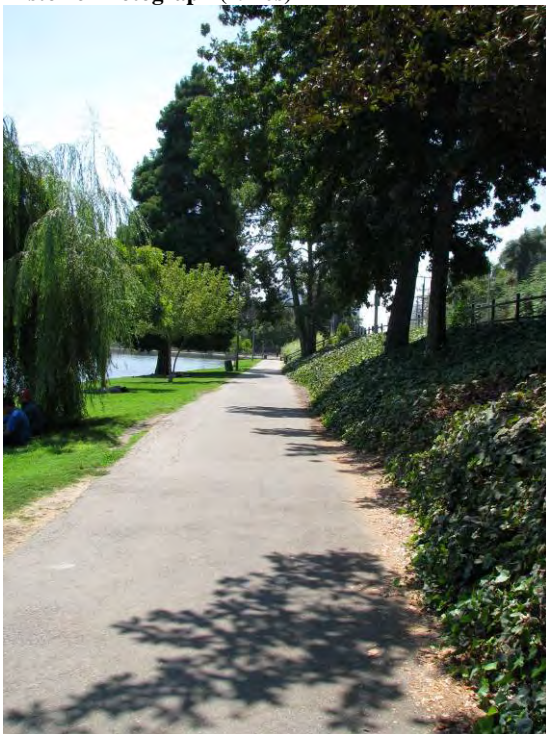
The pathway along Glendale Boulevard retains its long, straight character shown in the historic photograph (circa 1910s). It is tree-lined for much of its length, and retains the grade separation between the lake and road above.

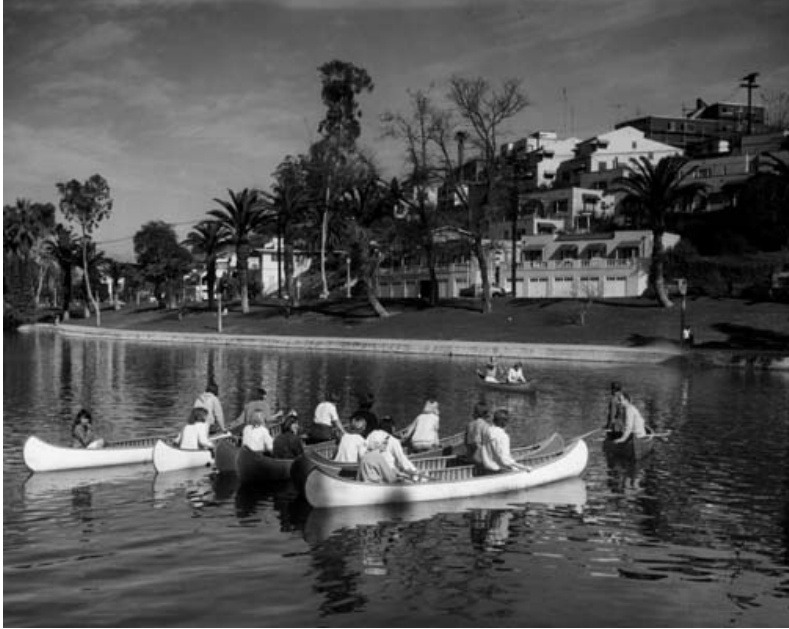
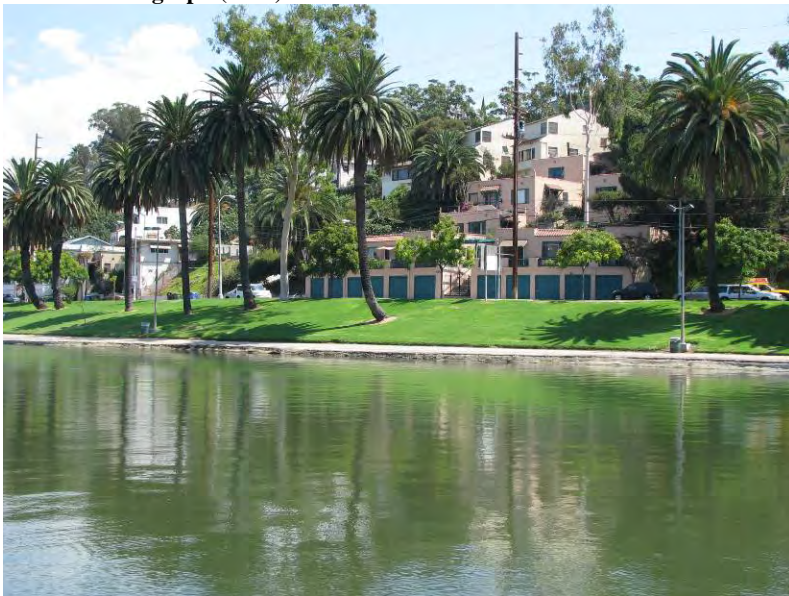
The historic photograph shown above was taken in 1965, when most of the understory vegetation had already been removed from the park or had died without being replaced. However, the grade change between the lake and the street above remain the same, as does the character of the setting of the park.

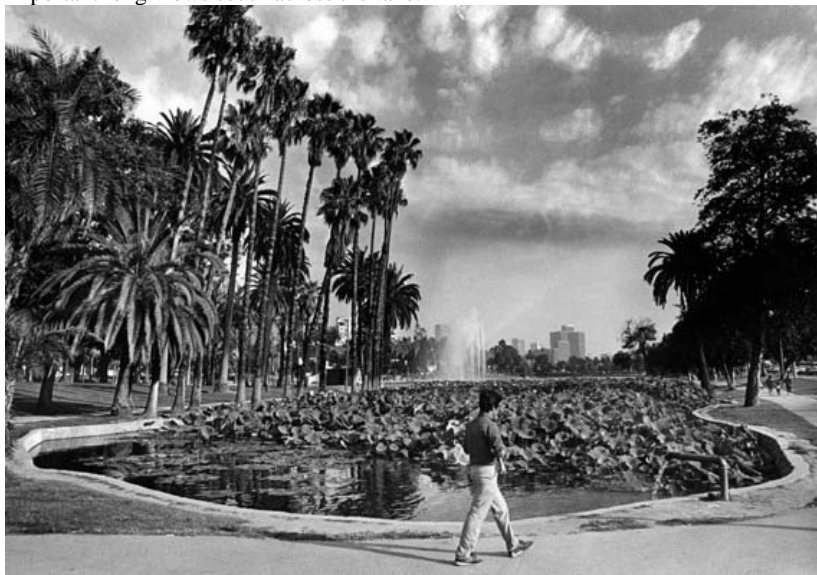
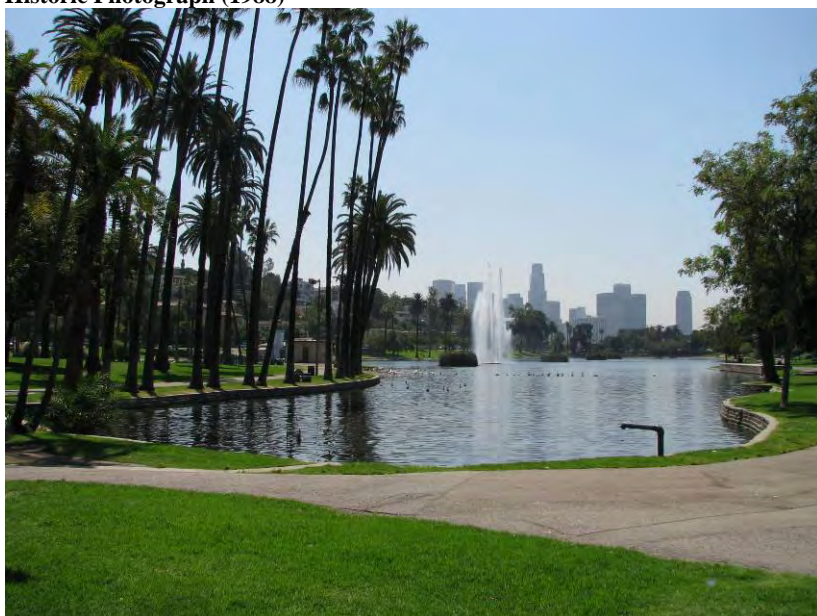
The lotus plants, in their full glory above (1988), have all but disappeared now. Other vegetation, such as the palms, remain to frame the important long views south across the lake.
